## Stability of Embankments on Soft Ground – Lessons from Failures

**Bujang B.K. Huat**

*Faculty of Engineering*

**Keywords:** embankment, failure, soft clay

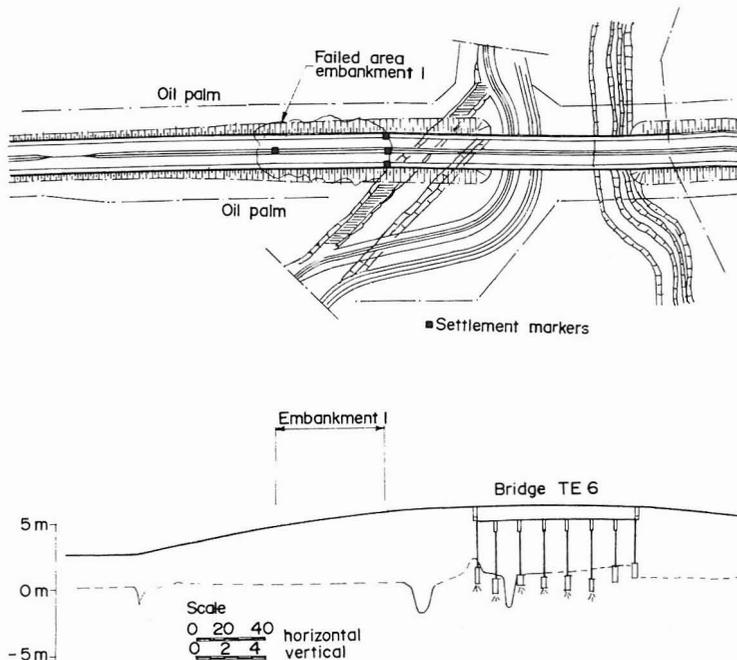
Fig. 1(a). Plan and profile of embankment 1

Fig. 1(a) shows location of Embankment 1. It lies north of an expressway bridge, located in the area of an oil palm plantation. The embankment was to be built on untreated soft clay foundation to a height of about 5 m with a side slope of 2 horizontal to 1 vertical. Tension crack was discovered at the left-hand side of the embankment by mid-July 1992, i.e. on Day 155 from start of filling. This was discovered as the final fill layer was being placed. The height of fill above original ground level was then about 4.6 m. On the following day the crack opened wider with more new cracks developing. On Day 158 about 1 m fill was removed and counterberm was constructed on the left-hand side to prevent complete collapse of the embankment.

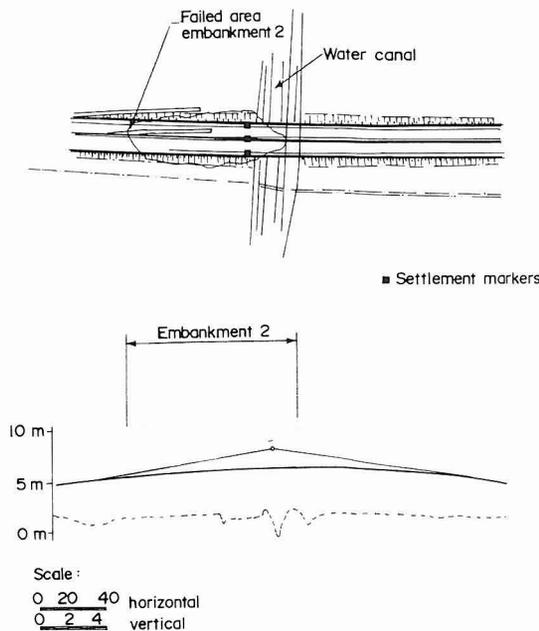
Fig. 1(b). Plan and profile of embankment 2

Fig. 1(b) shows location of Embankment 2 and its vicinity. The failed embankment lies just north of an existing water canal. Beneath the embankment vertical drains were installed to the full depth of the clay foundation (13 m) at a triangular grid spacing of 1.2 m centre to centre. Construction of the embankment commenced with placement of geotextile separator layer and 400 mm thick sand blanket in February 1992, followed by installation of the drain in May 1992. The earth filling was commenced by mid-June 1992 and was almost to the final level when the failure occurred at the end of October 1992, i.e. on Day 220 (Day 0 being placement of sand blanket). The fill thickness was then about 3.6 m above original ground level.

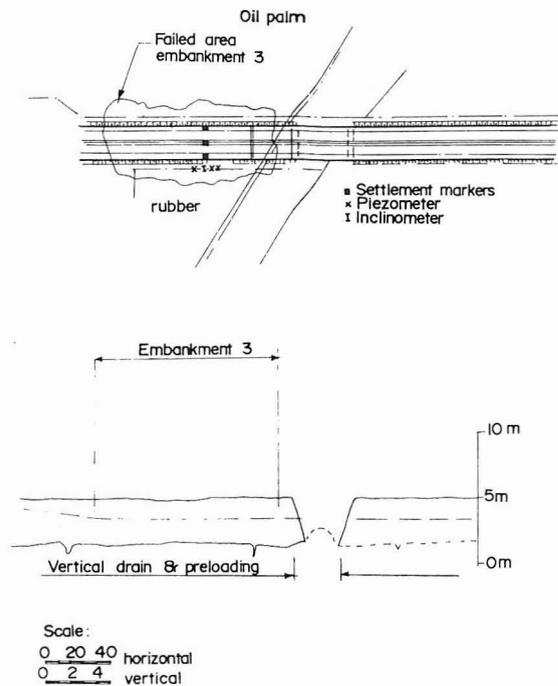
Fig. 1(c). Plan and profile of embankment 3

The location of Embankment 3 is shown in Fig. 1(c). This embankment transversed an area of rubber and oil palm estate. It was to be built to about 3.2 m height above original ground level, inclusive of a 1.5 m surcharge. Site clearing was commenced in early January 1992 followed by placement of geotextile separator layer with 400 mm thick sand blanket. Earth filling was commenced in early March 1992 and was completed to final level by mid-July 1992 (i.e. on Day 140). Five days later (Day 145) the embankment collapsed without prior sighting of any tension crack. It was reported that during construction the embankment was used as part of a haulage road for transportation of earth, piles and other construction materials from an existing

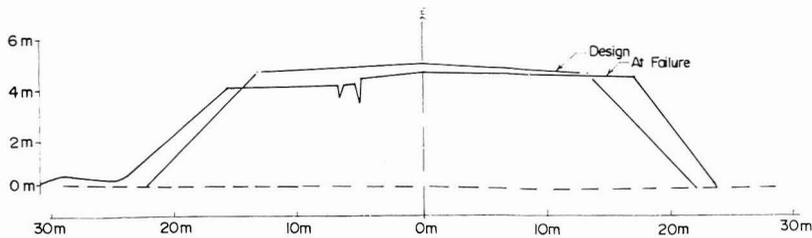
Fig. 4(a). Cross-section of embankment 1

Fig. 4 (a), 4(b) and 4(c). For comparison purposes, designed cross-sections of the embankment are superimposed. In all cases, failure of the embankment was characterized by wide open cracks through embankment fill with a significant heave at the embankment toe. This indicated that the mode of the embankment failure has been that of a rotational slip.

In the case of embankment 1, the cracks extend over a longitudinal distance of 80 m. A 0.25 m differential settlement was measured between the

failed and intact portions of the embankment. The toe heave extends over a distance of 7 m from the embankment toe.

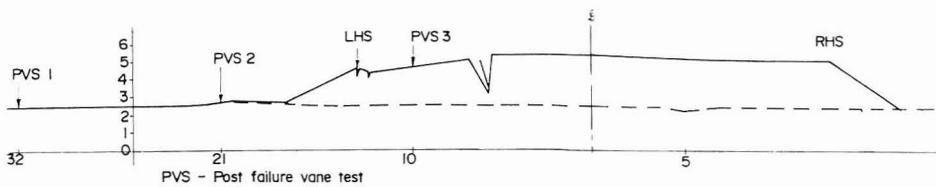
Fig. 4(b). Cross-section of embankment 2

In the case of embankment 2, the cracks extend over a longitudinal distance of 110 m. Movement of the ground beyond the embankment toe was in evidence over a distance of about 5 m.

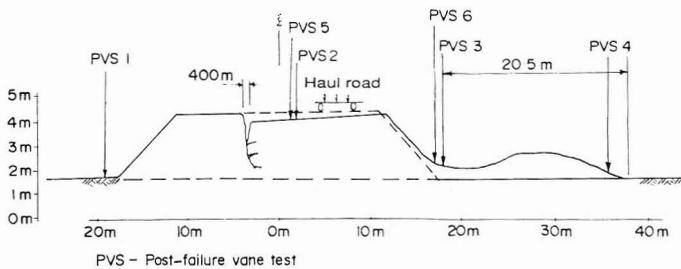
Fig. 4(c). Cross-section of embankment 3

In embankment 3, the failure stretched over a distance of 140 m. A crack about 400 mm wide (at surface) appeared about 4.0 m away from the centreline, with about 1 m differential settlement across the crack. A 1.26 m high heave was observed at the embankment toe, and the width of this upheaval was about 20.5 m.

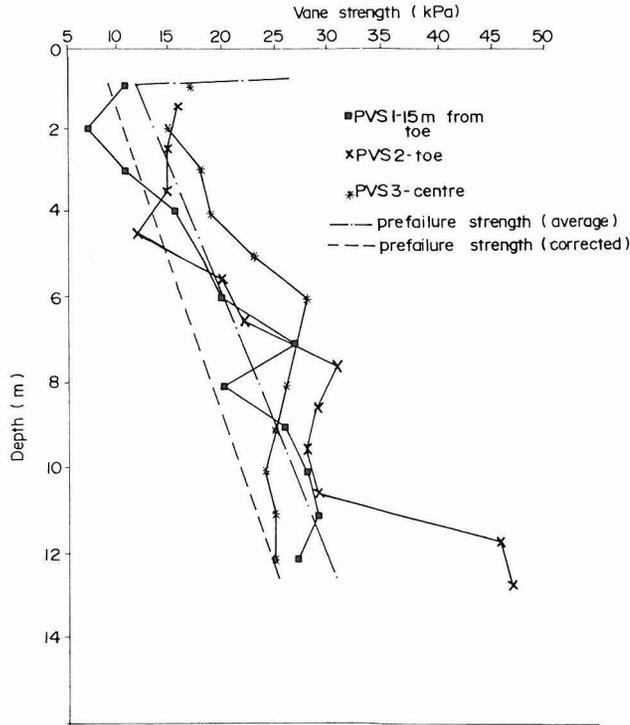
Fig. 5. Post-failure vane strengths of embankment 2

Post failure *in situ* vane shear tests were also carried out for embankments 2 and 3. Positions of the vane tests are shown in Fig. 4(b) and 4(c). For embankment 2, the vane measurements were carried out at a location close to the embankment centre, at toe and at a location about 15 m beyond the toe, about 1 month after the failure. The data obtained are presented in Fig. 5. Superimposed also on the figure are the average vane strengths of the initial (pre-failure) investigation (see also Fig. 3).

It is of interest to note that there appears to be no significant gain in shear strengths at locations beneath the embankment centre after construction. Note that at this particular embankment section prefabricated vertical drains were installed. There also appears to be no significant difference in undrained strength beneath the embankment centre compared with that at locations at the embankment toe, and away from the toe.

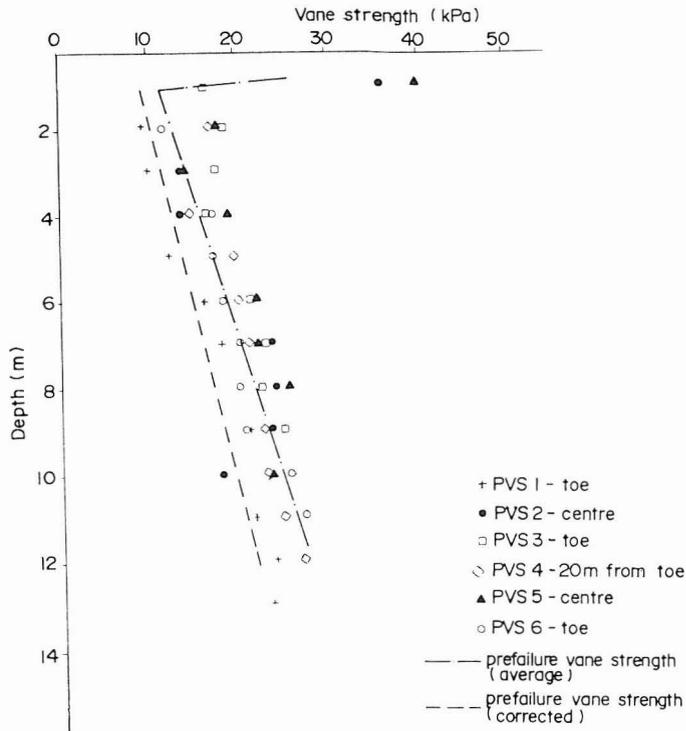
Fig. 6. Post-failure vane strength of embankment 3

Fig. 6 shows the post-failure vane strengths of embankment 3. These measurements were carried out in November 1992, three months after the failure. As in the case of embankment 2, there appears to be minimal strength gain when the post and pre-failure vane strengths are compared. It may therefore be concluded that the failure of both embankments 2 and 3 (and embankments 1) occurred essentially under undrained conditions. A

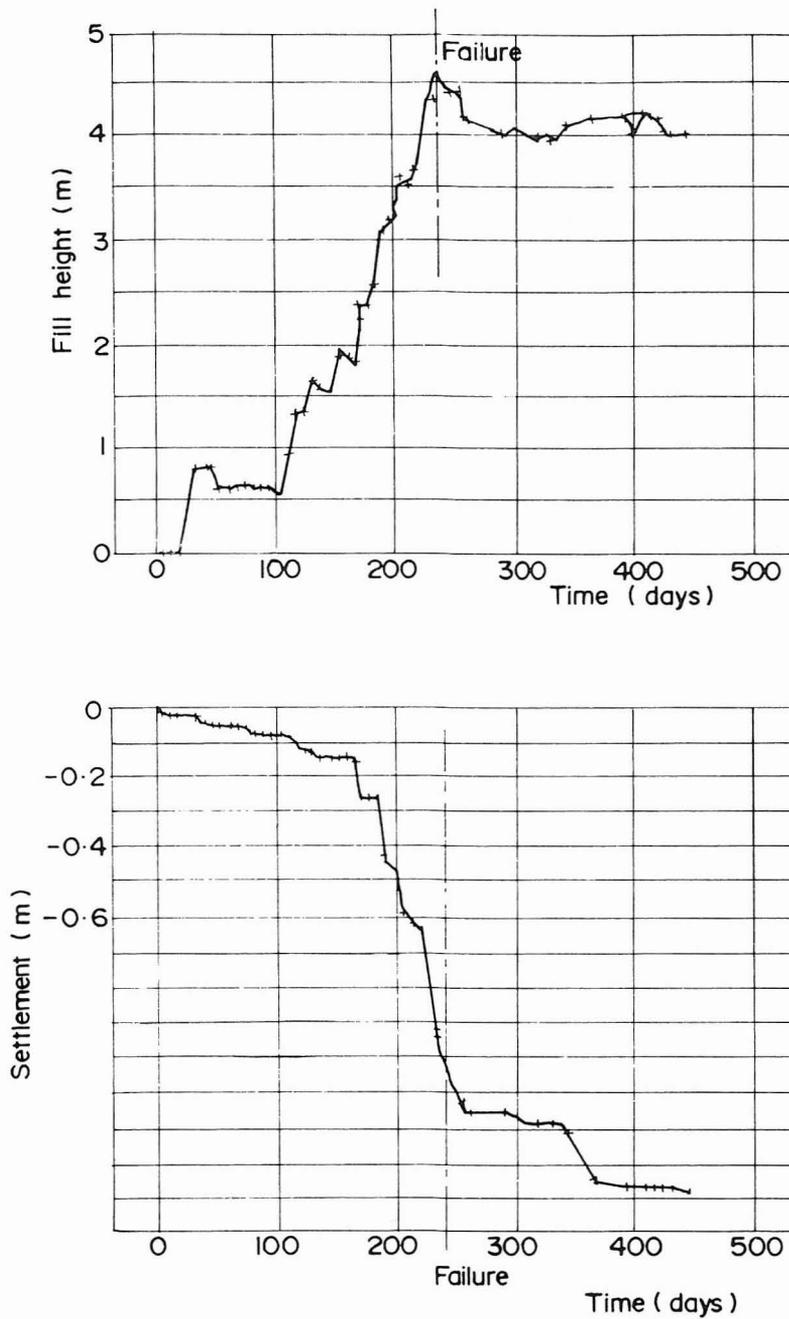
Fig. 8. Construction history and settlement of embankment 2

Fig. 8 and Fig. 9 show construction histories and settlements of embankment 2 and embankment 3 respectively. In both cases there was a dramatic increase in settlement rate just prior to the failure.

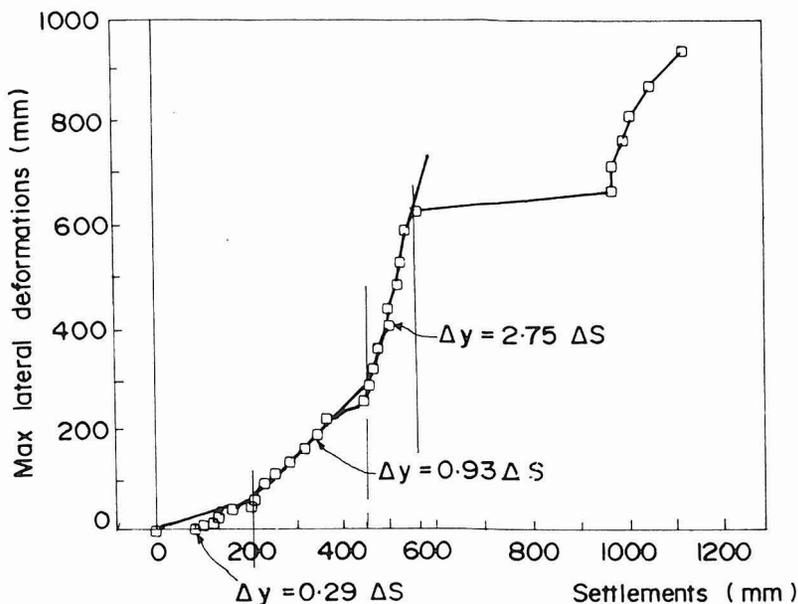
Fig. 10. Max lateral deformations – centreline settlements of embankment 3

Only embankment 3 was installed with an inclinometer and three piezometers in addition to the settlement markers. Fig. 10 shows plot of maximum lateral displacement ( $\Delta y$ ) versus centreline settlement ( $\Delta S$ ) of the embankment. It is of interest to note that when the fill was low, i.e. for fill thickness of less than 1 m, the  $\Delta y / \Delta S$  relation is small with  $\Delta y \cong 0.29 \Delta S$ . But at the onset of the failure,  $\Delta y$  increases significantly; from approximately equal to  $\Delta S$  to almost 3 times  $\Delta S$ .

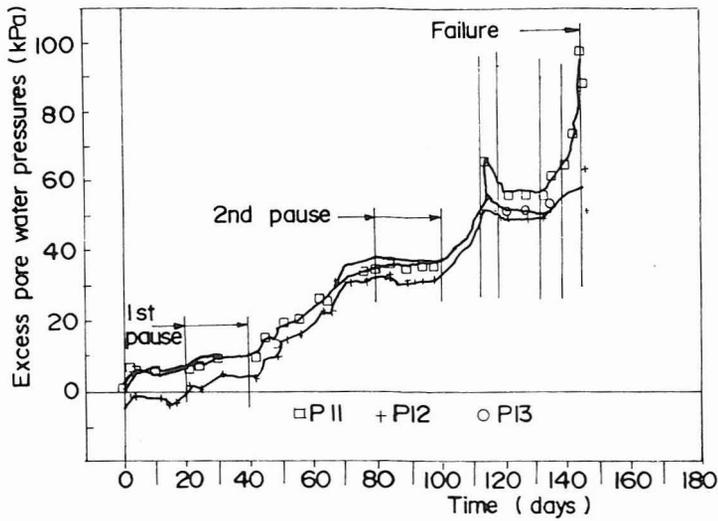
Fig. 11. Excess pore water pressure of embankment 3

The variation of excess pore water pressure ( $\Delta u$ ) with time of embankment 3 is shown in Fig. 11, while Fig. 12 shows plot of  $\Delta u$  with applied vertical stress,  $\Delta \sigma_v$ .

For low fill (less than 1 m), the piezometric response of the clay foundation is low;  $\Delta u = 0.44 \Delta \sigma_v$ . The increase in the pore water pressure then becomes approximately equal to the applied vertical stress. However, on the onset of failure, the piezometric response is large;  $\Delta u \gg \Delta \sigma_v$ . This is probably due to the following scenario. Prior to collapse of the embankment, local failures may have been initiated in the subsoil beneath the embankment. This results in strain softening, hence an increase in total horizontal stresses and pore water pressures. Therefore, prior to the failure one should expect  $\Delta u > \Delta \sigma_v$ , and this is shown in the pore pressure plot in Fig. 12. A similar observation of  $\Delta u > \Delta \sigma_v$ , at failure has also been made by D'Appolonia *et al.* (1971), and Davies and Parry (1985).
