Analysis of Longitudinal Cracks in Crest of Doroodzan Dam

KEYWORDS: Earth fill dam, Seepage, Longitudinal Crack, Doroodzan dam.

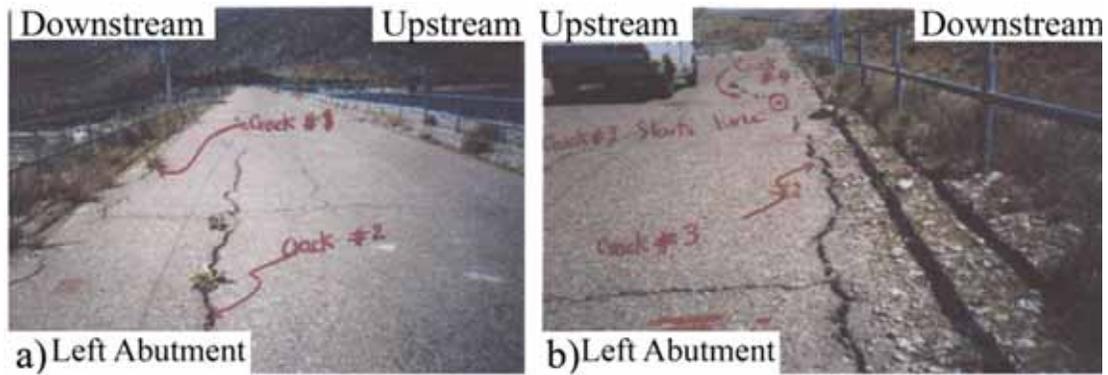
To start with, during first operation in 1972 of Doroodzan dam, small and large crack were observed in the left abutment of crest. It is always advisable to put down test pits to be sure that a crack is actually vertical and longitudinal and not a surface manifestation of inclined crack cutting through the dam core. If a crack is of appreciable depth and length, the engineer should try to prevent it from filling with surface water during observation and before it is sealed. Due to the test pit on crest location, it has defined that those cracks were not extend deep [5]. According to the results of test pit, the chief engineer did not order any injection or stabilizing method for available cracks in that time. However, in 1992 an impermeable vane was grouted there in order to reduce the water leakage from the left abutment. A recent research by Torabi, 2002 has illustrated, not only it was not useful to reduce the amount of leakage discharge but also it was one of the most important reasons of further cracks whereas during 1998 up to 2001, more than 72 new longitudinal cracks were appeared between 0+600 and 0+800 meter from right abutment in the left abutment [6]. Figure 2 shows some of the cracks in downstream side of crest in left abutment of Doroodzan dam.

Figure 2: Longitudinal cracks in study area

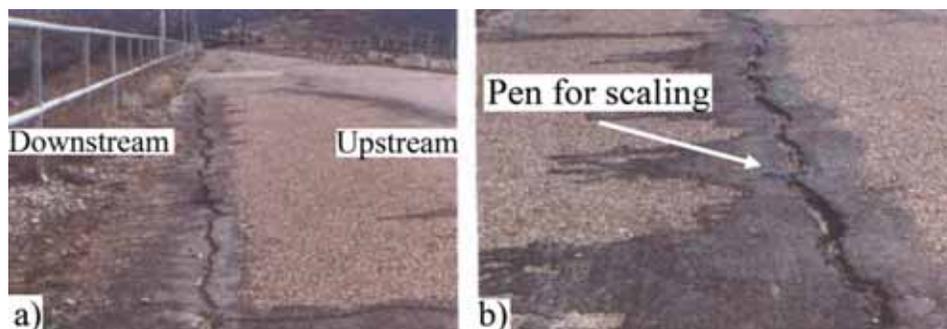
Figure 3: Stabilizing of cracks with grouting liquid asphalt

New cracks not only located in surface layers but also this time cracks penetrated through the cores. So new test pits have done to find cracks direction and depth [5]. Moreover, test pits were conducted in Doroodzan dams to find more about crack direction. There is some evidence where it can be seen changing water level in reservoir did actually lead to changing in cracks width. For instance, by filling or drawdown of reservoir crack width changed and become more serious problem throughout operation years. Furthermore, in dry seasons which the level of reservoir did not have any significant increases, only small change in crack size were observed. As it can be seen from the Figure 3, initial countermeasure liquid asphalt was grouted to filling between cracks.

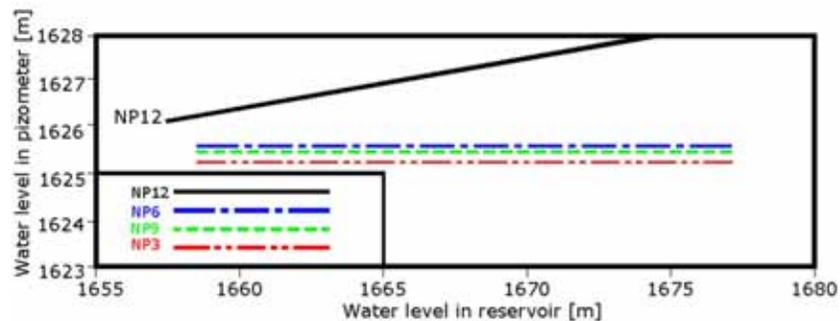
The most reliable piezometers which can be mentioned here are NP_1 to NP_{14} . As could be seen from the Figure 1, they were located in 4 transverse and 3 longitudinal directions. Due to the fact that NP_3 , NP_6 , NP_9 and NP_{12} placed after the chimney drain, consequently, changing in water level in reservoir should not have any influence on water head in these piezometers. However as it is monitored after grouting impermeable vane from the Figure 4, NP_{12} showed a different behavior. In fact increasing in water level in reservoir did actually lead to increasing in NP_{12} piezometric head. It could be due to expanding saturated area which made by water infiltration from left abutment.

Figure 4: water head change in piezometers NP_3 , NP_6 , NP_9 and NP_{12} .

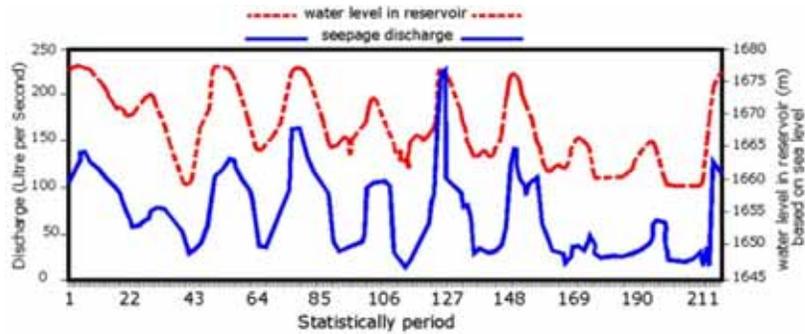
After exploration of abutment leakage condition which was from loan rock, in 1992 both right and left abutments, an impermeable vane was grouted [7]. Since after grouting in left abutment, a small stream in downstream defined which flow to the toe drain of dam. The amount of leakage discharge is directly related to the water level in reservoir. This can be seen in Figure 5.

Figure 5: Directly relation between both water levels in reservoir and leakage discharge in left abutment

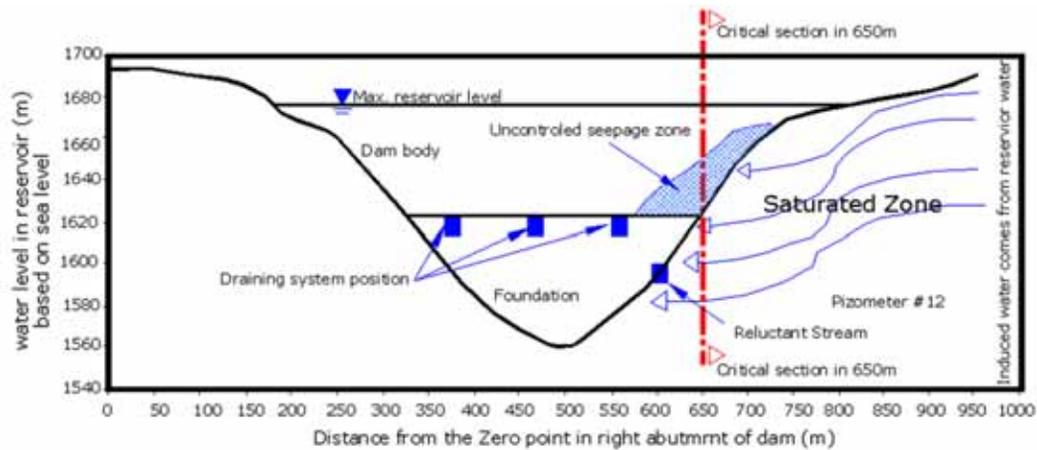
In glimpse, grouting impermeable vane leads to more vulnerable slopes in downstream, caused by expanding the saturated zone which has depicted in Figure 6. In fact between 0 + 600 and 0 + 800, leakage caused a significant change in material properties and actually it gives rise to increasing in the number of longitudinal cracks in the left abutment of Doroodzan dam.

Figure 6: critical section in Doroodzan dam

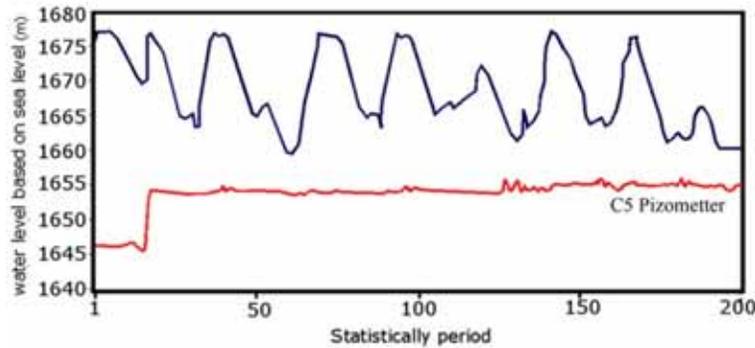
Undoubtedly the amount of leakage is related to water level in reservoir. When filling reservoir has done, consequently, water stays in the study area (650 meter from the zero point in the right abutment) until next draw down, so it could be very dangerous for downstream stability. Perhaps it reflects decreasing in shear strength parameters of downstream material in study area. Besides, it is worth being noting that by increasing in area of saturated zone, problem become more serious. Figure 7 shows the change in C_5 , one of the old piezometers in study area. As can be observed from this graph after the impermeable vane was grouted in 1992, water head in this piezometer sharply soar from 1645 to 1654 and it remains constant in 1654. It is worth being mentioning that this piezometer might be damaged and it has not been working throughout these years.

Figure 7: Changing water head in C_5 , before and after grouting impermeable vane
