ULTRASONOGRAPHIC IMAGING ON THE PROGRESS OF WOUND HEALING AFTER ABDOMINAL SURGERY IN DOGS

A.B.Z. Zuki¹ and J.S. Boyd²

SUMMARY

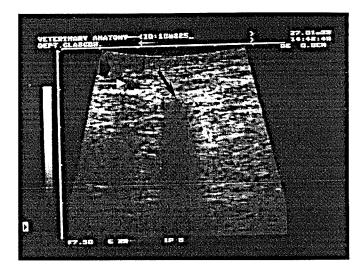
Fig. 1. Transverse scan of the ventral abdominal wound approximately 24 hours post-operation demonstrated an ill-defined hypoechoic area with acoustic shadowing artefact (arrow). The rectus abdominis muscle on both sides of the wound appears well defined and almost isoechoic relative to the subcutaneous tissue. The edges of the wound appear to have well apposed. The wound on the skin and subcutaneous tissue appears hypoechoic with acoustic shadowing artefact (arrow head) and is not parallel with the wound in muscle. A small fluid accumulation within the subcutaneous tissue (small arrow) appears anechoic.

Ultrasonographic examination of the ventral abdominal wound scanned transversely on day one (approximately 24 hours) post-operation demonstrated a wound which appeared as an ill-defined hypoechoic area with acoustic shadowing artefact (Fig. 1). The rectus abdominis muscle on both sides of the wound appeared well defined and almost isoechoic relative to the subcutaneous tissue. The edges of the wound appeared to have been well apposed. A small fluid accumulation within the subcutaneous tissue at the surgical site of the skin appeared anechoic with ill-defined margins. The wound was found to be exactly on the linear alba, but at a certain point was found on the muscle just lateral to the linear alba. The suture material within the subcutaneous tissue appeared hyperechoic with acoustic shadowing artefact.

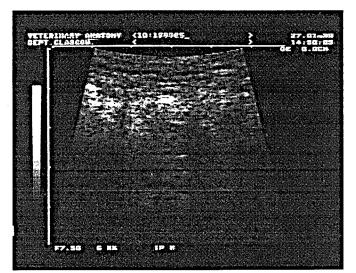
Fig. 2. Longitudinal scan along the ventral abdominal wound approximately 24 hours post-operation demonstrates a disorganised pattern of muscle with intermittent acoustic shadowing which is due to suture material in the skin.

Longitudinal scan along the wound demonstrated a disorganised pattern of muscle with intermittent acoustic shadowing originating from the skin surface which was due to suture material in the skin (Fig. 2). Areas of haemorrhage and small fluid accumulations within the subcutaneous tissue appeared anechoic to hypoechoic with acoustic shadowing artefacts.

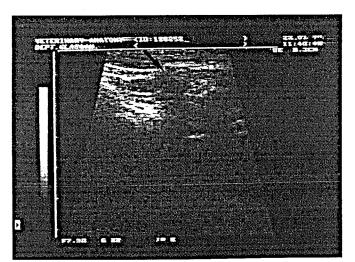
Fig. 3. Transverse scan of the ventral abdominal wound on day two post-operation demonstrates an ill-defined hypoehoic area (arrow) with acoustic shadowing artefact.

Transverse scan on ventral abdominal wound demonstrated an ill-defined hypoechoic area with acoustic shadowing artefact (Fig. 3). The supposed haemorrhagic area within the subcutaneous tissue superficial to the rectus abdominis muscle was still visible and appeared as an illdefined hypoechoic area with acoustic shadowing artefact. The area of muscle damage appeared disorganised and hypoechoic. Areas of supposed haemorrhage and small fluid accumulation within the subcutaneous tissue were still present and appeared anechoic to hypoechoic with acoustic shadowing artefact on the longitudinal scan.

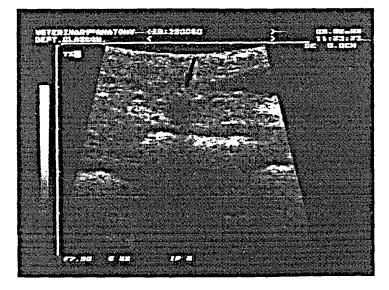
Fig. 4 Transverse scan of the wound on day 11 postoperation demonstrates a disorganised hypoechoic area (arrow) with an echogenic centre and casting acoustic shadowing artefact. The echogenic area of the wound is suggestive of the presence of fibrous tissue formation which is essential for the wound healing process. Note also the area surrounding the surgical site appears disorganised suggestive of soft tissue damage.

The scanning was done a day after removal of suture material. Transverse scan of the ventral abdominal wound demonstrated a disorganised hypoechoic area with an echogenic center, casting an acoustic shadowing artefact (Fig. 4). The echogenic area of the wound was suggestive of the presence of fibrous tissue formation which was essential for the wound healing process. The area surrounding the surgical site appeared disorganised and hypoechoic suggestive of soft tissue damage.

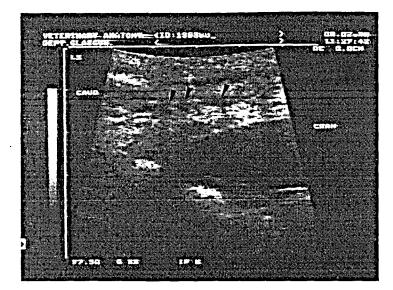
Fig. 5. Longitudinal scan of the ventral abdominal wound on day 11 post-operation demonstrates a disorganised hypoechoic to echogenic structure representing the area of muscle damage with intermittent acoustic shadowing artefacts emanating from the ill-defined hypoechopic areas (arrow heads). These hypoechoic areas are actually the original site of the suture material and have been filled by serum and cellular debris.

Longitudinal scan of the ventral abdominal wound demonstrated that the wound appeared as a disorganised area of mixed echogenicity indicating an area of muscle damage with intermittent acoustic shadowing artefacts emanating from the ill-defined hypoechoic areas within the muscle (Fig. 5). These ill-defined hypoechoic areas were actually the original sites of the suture material which had been infiltrated by serum and cellular debris.

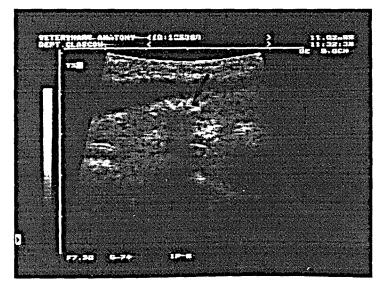
Fig. 6. Transverse scan of the ventral abdominal wound on day 11 post-operation demonstrates a disorganised echogenic area (arrow) casting an acoustic shadowing artefact. The area surrounding the surgical site appears more organised than on the previous scan. Note also the fluid filled area is still present.

Ultrasonographic examination of the ventral abdominal wound demonstrated a disorganised echogenic area with acoustic shadowing artefact (Fig. 6). The area surrounding the surgical site appeared more organised than on the previous scan. The large fluid accumulation with acoustic enhancement artefact separating the subcutaneous tissue and rectus abdominis muscle was still present. A small portion of fibrous tissue formation was seen protruding into the fluid space at the surgical site.

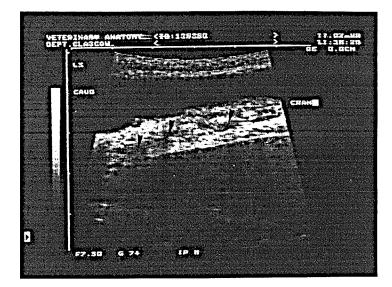
Fig. 7. Longitudinal scan of the ventral abdominal wound on day 13 post-operation demonstrates a disorganised echogenic area representing the muscle damage with the presence of fibrous tissue formation. Small hypoechoic areas (arrow heads), which are casting intermittent acoustic shadowing artefacts are still visible but appear smaller than on the day 11 examination. These hypoechoic areas represent the site of suture material undergoing reabsorption. The overall increase in echogenicity is due to acoustic enhancement artefact caused by fluid accumulation.

Longitudinal scan of the wound demonstrated a disorganised echogenic structure representing the area of muscle damage with the presence of fibrous tissue formation (Fig. 7). The small hypoechoic areas which were casting intermittent acoustic shadowing artefact were still visible but appeared smaller than on day 11 examination. These hypoechoic areas represented the original sites of the reabsorbing suture material. There was some echogenic material present within the fluid area suggesting that this was consolidating.

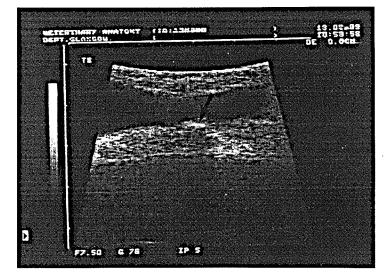
Fig. 8. Transverse scan of the ventral abdominal wound on day 15 post-operation demonstrates a disorganised hyperechoic area (arrow) with acoustic shadowing artefact. Fibrous tissue appears to have an hyperechoic appearance compared to the image on the day 13 post-operation. The large fluid accumulation between the subcutaneous tissue and rectus abdominis muscle is still present.

Ultrasonographic examination of ventral abdominal wound demonstrated a disorganised hyperechoic structure with acoustic shadowing artefact (Fig. 8). The fibrous tissue appeared more hyperechoic compared to the image on the day 13 post-operation. The large fluid accumulation between the subcutaneous tissue and the rectus abdominis muscle was still present. The presense of echogenic material indicated that there was consolidation taking place.

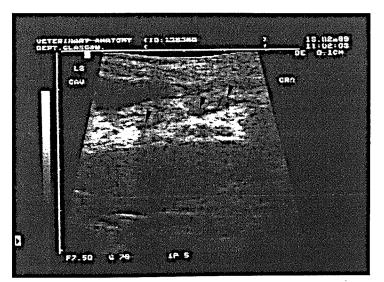
Fig. 9. Longitudinal scan of the ventral abdominal wound on day 15 post-operation demonstrates a disorganised hyperechoic structure with the presence of some hypoechoic areas producing acoustic shadowing artefacts (arrow heads). These small hypoechoic areas within the muscle are actually the site of suture material being reabsorbed and are visible on ultrasound. The disorganised hyperechoic structure is due to the presence of fibrous tissue formation.

Longitudinal scan demonstrated a disorganised hyperechoic structure with the presence of some hypoechoic areas producing acoustic shadowing artefact (Fig. 9). These small hypoechoic areas within the muscle represented the original sites of suture material and were still visible on ultrasound. The disorganised hyperechoic structure was due to the presence of fibrous tissue formation.

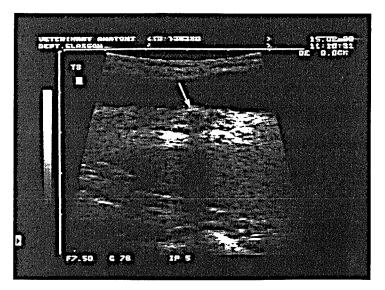
Fig. 10. Transverse scan of the ventral abdominal wound on day 17 post-operation demonstrates a disorganisd hyperechoic area (arrow) with acoustic shadowing artefact. The wound appears somewhat smaller than on day 15 examination. The large fluid accumulation is still present and appears as in the previous scan.

Transverse scan of the ventral abdominal wound demonstrated a disorganised hyperechoic area with acoustic shadowing artefact (Fig. 10). The overall dimensions of the wound appeared to be smaller than on day 15 examination. The large fluid accumulation was still present and appeared as in the previous scan. Longitudinal scan of the surgical site demonstrated a disorganised hyperechoic area representing the area of muscle damage and the presence of fibrous tissue formation (Fig. 11). The small hypoechoic areas with acoustic shadowing artefacts could still be seen.

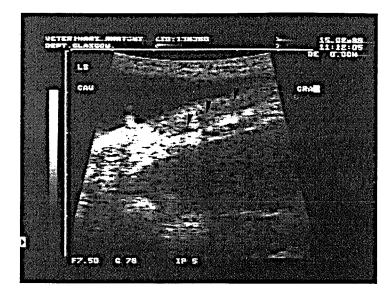
Fig. 11. Longitudinal scan of the ventral abdominal wound on day 17 post-operation demonstrates a disorganisd hyperechoic area representing the area of muscle damage and the presence of fibrous tissue formation. Note also the hypoechoic areas (arrow heads) with acoustic shadowing artefacts still visible.
