Defect Detection of GFRP Composites through Long Pulse Thermography Using an Uncooled Microbolometer Infrared Camera

Abstract: The detection of impact and depth defects in Glass Fiber Reinforced Polymer (GFRP) composites has been extensively studied to develop effective, reliable, and cost-efficient assessment methods through various Non-Destructive Testing (NDT) techniques. Challenges in detecting these defects arise from varying responses based on the geometrical shape, thickness, and defect types. Long Pulse Thermography (LPT), utilizing an uncooled microbolometer and a low-resolution infrared (IR) camera, presents a promising solution for detecting both depth and impact defects in GFRP materials with a single setup and minimal tools at an economical cost. Despite its potential, the application of LPT has been limited due to susceptibility to noise from environmental radiation and reflections, leading to blurry images. This study focuses on optimizing LPT parameters to achieve accurate defect detection. Specifically, we investigated 11 flat-bottom hole (FBH) depth defects and impact defects ranging from 8 J to 15 J in GFRP materials. The key parameters examined include the envi

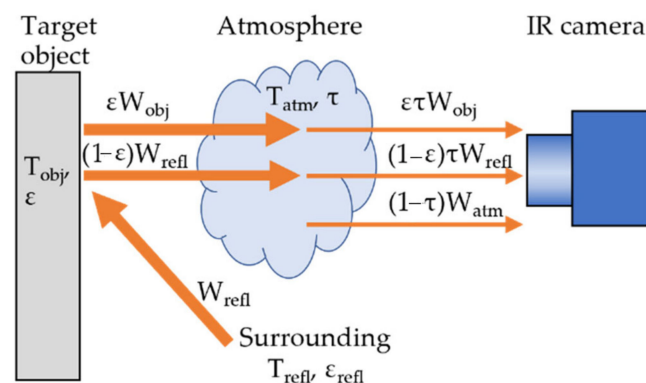
Figure 1. Radiation captured during data measurement using an IR camera [33].

During thermographic testing, the total radiation received by the IR camera comprises radiation from the sample, reflections, and atmospheric contributions. Surface material emissivity significantly influences the accuracy of GFRP defect detection. Figure 1 illustrates temperature measurements using an IR camera [33]. To minimize noise and enhance data accuracy, it is essential to control parameters such as the atmospheric conditions, environmental temperature, weather, and background reflections [34,35]. Various studies have investigated the impact of environmental conditions, such as ambient temperature and weather (sunny, rainy, and windy), on the assessment of construction material defects [36]. Indoor background reflections can stem from furniture, wallpaper, uneven painting, walls, surface roughness, and other factors, including wall color [34,37,38]. High background reflections can falsely elevate the temperature of the material being tested, leading to erroneous defect identification. Improvements for reducing background reflection include using polarizers attached to IR cameras [39] or specific post-processing algorithms [40,41]. Additionally, closed chambers or apparatuses can be employed to minimize reflection [42–44]. While standards and guidelines for thermographic NDT methods for detecting delamination in buildings and bridge concrete structures exist [35,45–47], guidelines for using LPT thermography with uncooled, low-resolution IR cameras to assess composite defects have yet to be established.

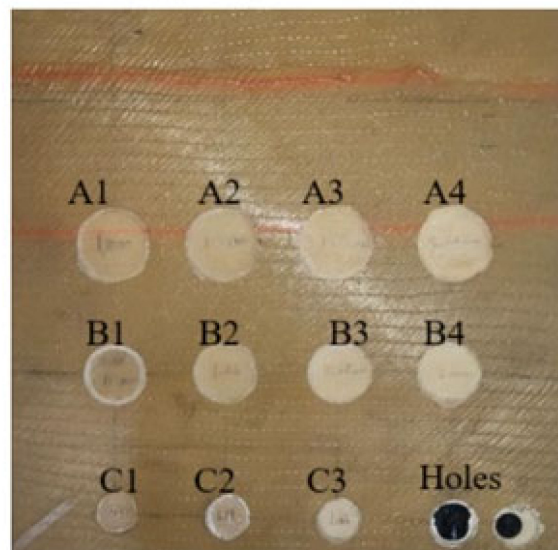
Figure 2. Front rear of the eleven flat bottom holes (FBH) of the GFRP sample.

Two small holes were intentionally created as references to distinguish between subsurface FBH defects and actual holes. The sizes and depths of each FBH defect are detailed in Table 1. Two medium-impact damage square shape samples, labeled IM1 and IM2 as shown in Figure 3, consisting of 14 layers of unidirectional roving with the dimensions of 150 mm × 150 mm at 6 mm of thickness, were also prepared using the same material. The impact energies were 8 J and 15 J, respectively. A striker, weighing 5.101 kg and featuring a hemispherical tip with a 5 mm radius, was used. The speed of the impact test is the gravitational acceleration = 9.81 m/s². The magnitude of impact energy varied according to the height from which the striker was released on the sample, as described by Equation (1).

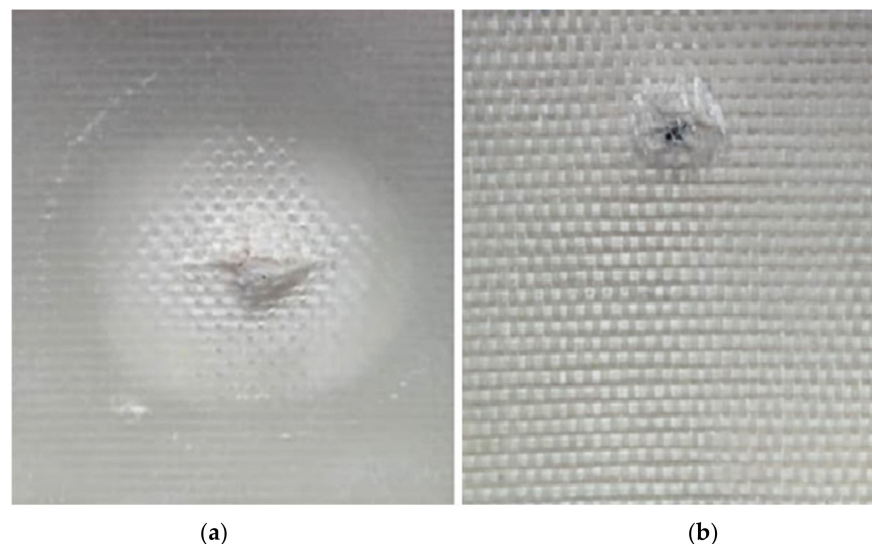
Figure 3. Impact defect of the GFRP sample: (a) sample IM1 and (b) sample IM2.

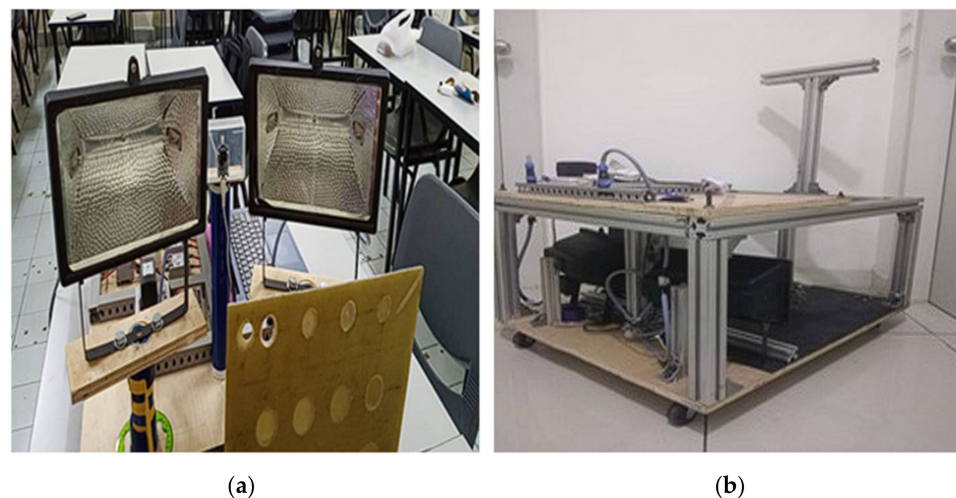
Figure 4. LPT setup using (a) reflex configurations and (b) an enclosure.

The experiment utilized a long pulse thermography (LPT) setup in a reflex configuration. Two sets of 1 kW halogen lamps served as the heating sources. The tests were conducted in both open and closed setups using an enclosure, as illustrated in Figure 4. In the reflex configuration, the camera and heat source were positioned on the same side, facing the sample, with each heating source angled between 25° and 30°. A flexible rail was attached to hold the sample, allowing it to be moved back and forth to adjust the heating distance between the heat source and the sample. The IR camera used in this research was an uncooled FLIR Lepton 3.5 IR camera, with an NETD of less than 50 mK and a resolution of 160 × 120. The IR camera detects wavelengths in the range of 8–14 μm.

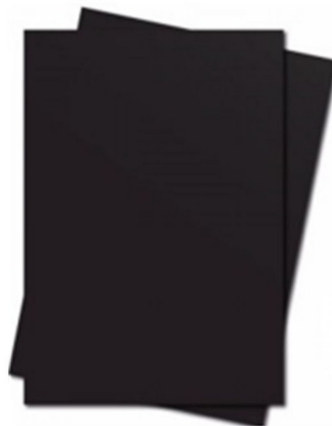
**Figure 5.** Example of black-colored paper used in the experiment.

Even though this research uses an enclosure to reduce the amount of external noise, it is important to minimize the background reflection that comes from the internal enclosure, especially with the application of an uncooled microbolometer IR camera that has a high NETD. A study showed that there were varying results in the application of different types of IR cameras for the detection of color painting defects [63]. Moreover, studies using a close setup are also being conducted using black color material, such as a black blanket [32] or a blackbody testing furnace [38]. This has shown that the internal background color of the enclosure influences the effectiveness of defect detection using a thermography system. The experiment was conducted by covering the internal walls of the enclosure with paper of three different colors: yellow, white, and black, with emissivity values of 0.68, 0.72, and 0.90, respectively (thermoworks.com/emissivity-table/ (accessed on 5 August 2024), as shown in Figure 5. The study was conducted indoors at a low temperature (16 °C to 18 °C).

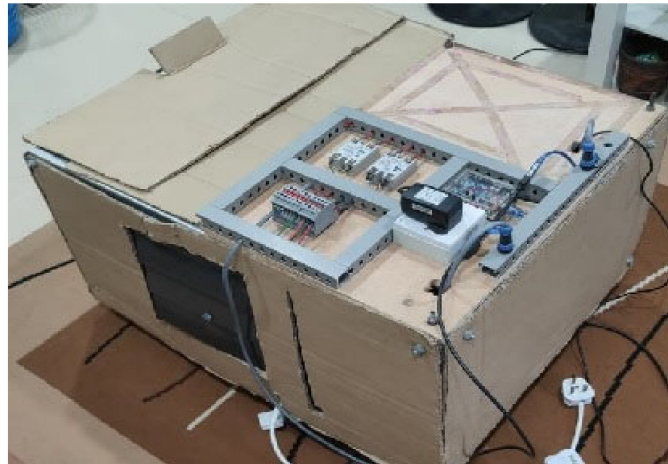
Figure 6. Close setup of the enclosure using hard cardboard.

studied both with and without an enclosure, representing open and closed setups. The study was conducted indoors at a low temperature (16 °C to 18 °C). A closed setup was also tested using an enclosure made of hard cardboard, as shown in Figure 6.

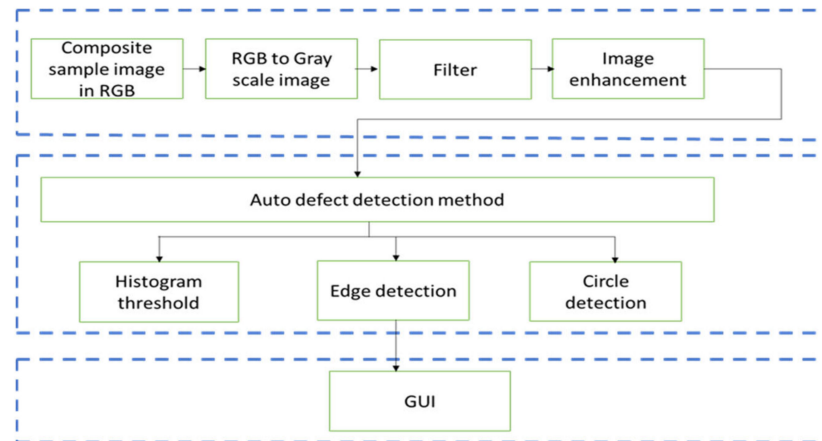
Figure 8. Image-segmentation method for automatic defect detection.

image segmentation approaches, each exhibiting different features for automatically identifying FBH depth and impact defects in GFRP samples [67]. Automatic defect detection is crucial in industrial applications, as it enhances manufacturing efficiency by enabling quicker decisions on sample acceptance and rejection without relying on skilled workers to interpret raw images. Figure 8 shows the flowchart of the image-processing method applied in this study. The process flow is divided into three sections as shown in blue dotted boxes.

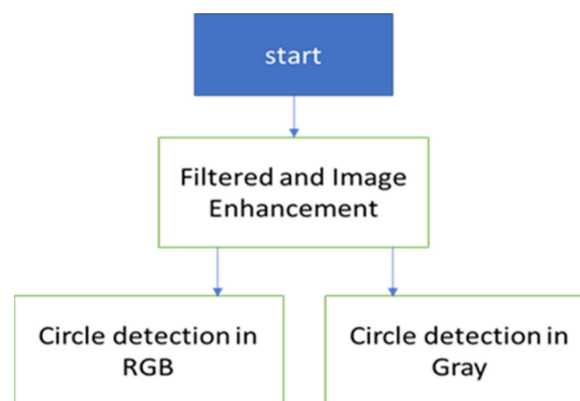
Figure 10. Circle detection algorithm flowchart.

Another promising segmentation method for automatic defect detection is histogram thresholding, a technique used in various fields such as brain tumor detection [70]. Identifying an optimal histogram threshold value is crucial to ensuring no defects are missed and no noise is included in the process. In this method, the optimal threshold for histogram segmentation was set at 200, resulting in a binary image where the defective areas are represented by white (logic 1). FBH defects typically represent manufacturing defects such as voids and bubbles, while impact defects arise from operational incidents such as collisions or impacts. FBH depth defects are usually round-shaped, while impact defects lack specific shapes. Therefore, in this research, a circle detection algorithm, known as the Circular Hough Transform (CHT) algorithm, was appropriate for detecting FBH depth defects. The algorithm was applied to both grayscale and RGB images, as shown in Figure 10.

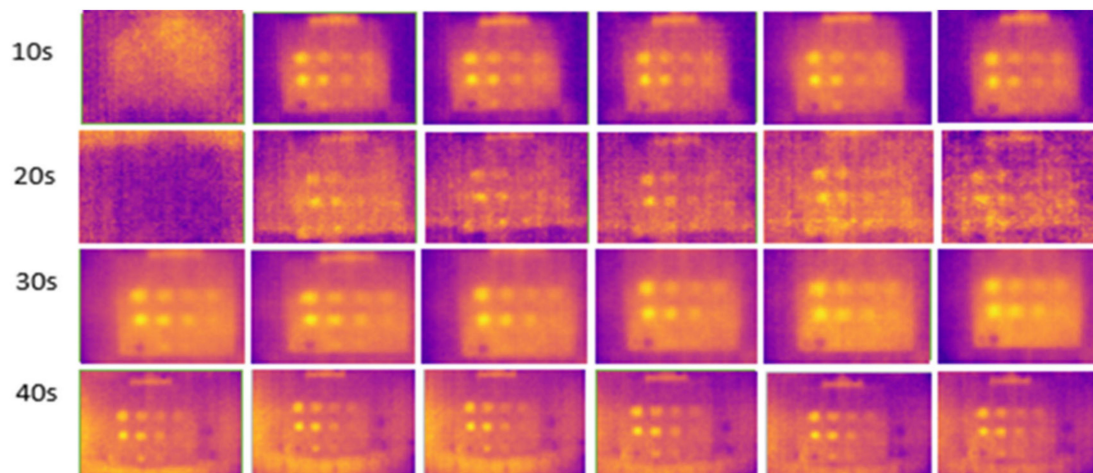
Figure 11. Outdoor output image at temperatures above 35 °C for 10–40 s of heating duration.

The results for outdoor temperatures from 35 °C to 37 °C are shown in Figure 11, compared with indoor temperatures from 23 °C to 25 °C (room temperature) and from 16 °C to 18 °C (low temperature in an air-conditioned room), as shown in Figures 12 and 13, respectively.

During the experiment, ten image frames were continuously captured, but only six images were recorded at the horizontal position at each heating period shown in each figure. These images were used to highlight the effect of temperature changes on the material. Figure 14 shows the temperature bar for one of the sample images captured outdoors at a temperature above 35 °C. The result showed that the temperature is not evenly distributed. The temperature in the defective areas varies from 45 °C to 55 °C. It

is also demonstrated that the images captured outdoors were unclear and noisy. As the heating duration increased, the results remained constant, without any improvement. The experiment demonstrates that indoor tests produce less noise compared to outdoor tests due to controlled surrounding temperatures, eliminating radiation caused by external heat sources, particularly solar radiation. At 10 s of heating, the results at room temperature and air-conditioned room temperature showed very few FBH composite defects detected, indicating insufficient heating on the material's surface to produce a significant temperature contrast between defective and non-defective areas. As the heating duration increased to 20 s, more defects were detected, achieving a 91% detection rate. The B1 defect was detected with low observability, while the C1 defect showed very low observability, making it undetectable. Both defects have the highest depth at 2.88 mm but have different diameters. At room temperature, similar detection results appeared but required longer heating durations (30 s). However, as the heating duration extended to 40 s, the defective areas on the samples became less evident and started to vanish because the surface temperature of the samples equalized between defective and non-defective areas.

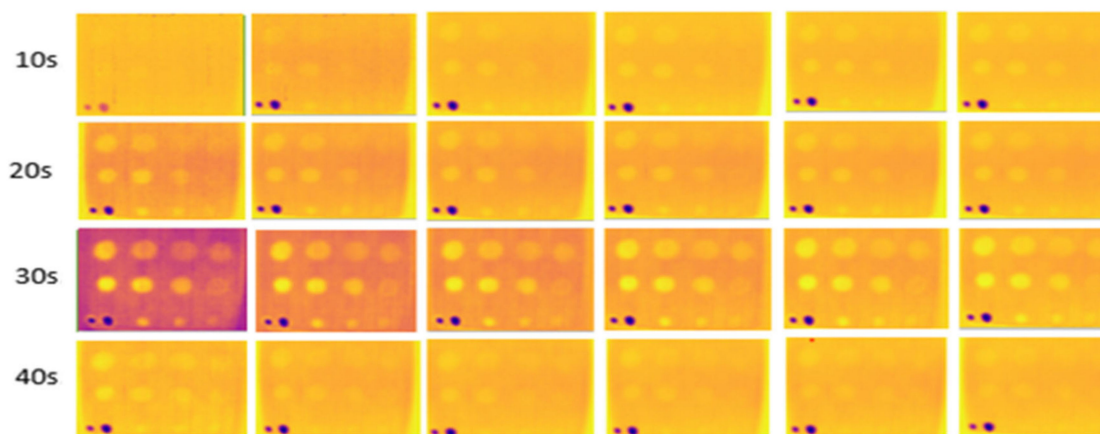
Figure 12. Indoor output image at room temperature (23–25 °C) for 10–40 s of heating duration.

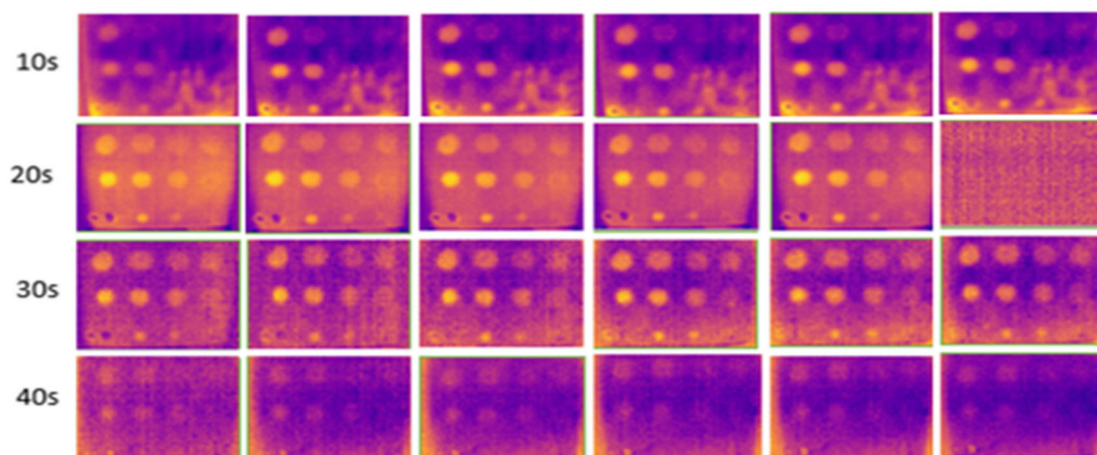
Figure 13. Indoor output image at low temperatures (16–18 °C) for 10–40 s of heating duration.

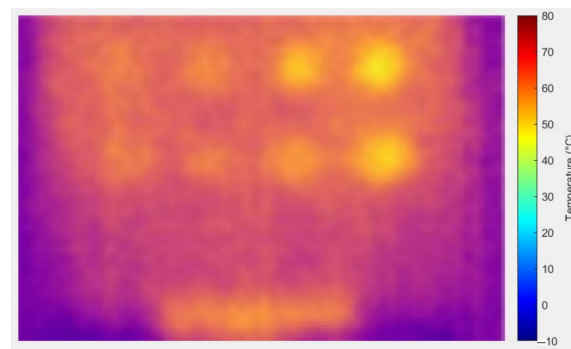
Figure 14. Temperature bar for one of the images captured outdoors at temperatures above 35 °C.

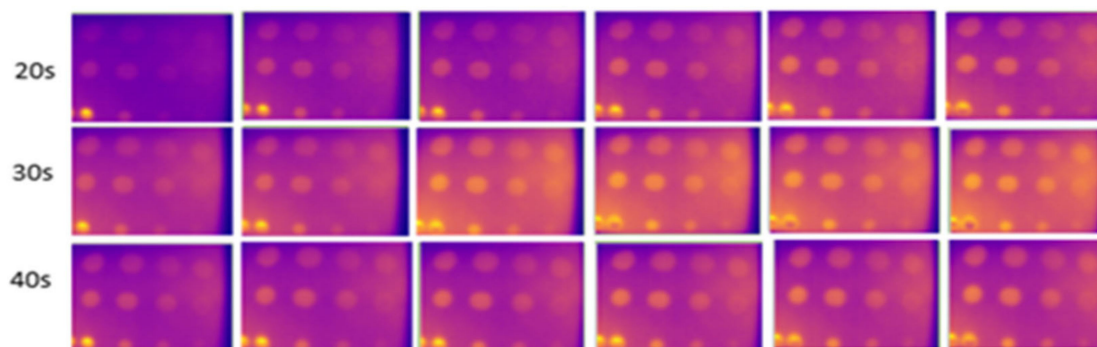
Figure 15. Output image for the black-colored background of the internal wall for 20–40 s of heating.

This experiment, conducted indoors at low temperatures (16 °C to 18 °C), focused on three different internal background colors of the enclosure. Heating durations were limited to 20 to 40 s, as this range adequately captured the thermal contrast between defective and non-defective areas. Images captured against a black background, as shown in Figure 15, had higher clarity, less noise, and more observable defects compared to those captured against white and yellow backgrounds, shown in Figures 16 and 17. At 30 and 40 s of heating, the black background achieved optimal defect detection (91%). However, the B1 defect had poor visibility and the C1 defect was undetectable due to their size and depth. The heat absorption by the black background, with an emissivity close to 1, minimized reflection and noise, resulting in clearer defect detection.

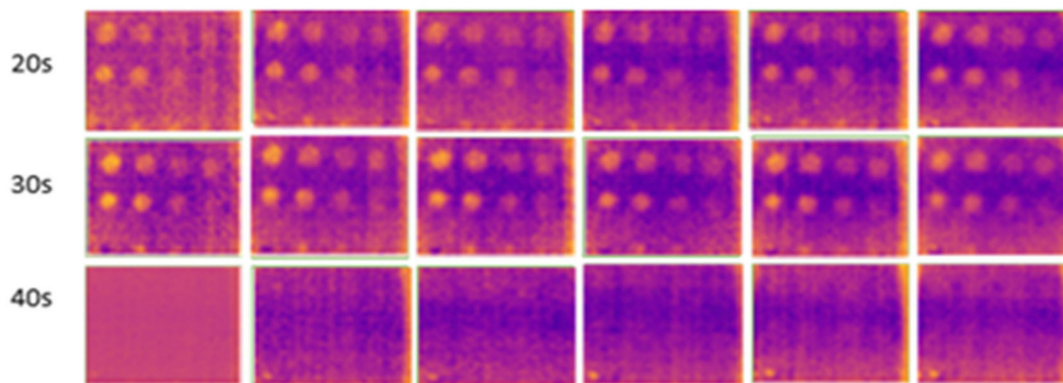
Figure 16. Output image for the white-colored background of the internal wall for 20–40 s of heating.

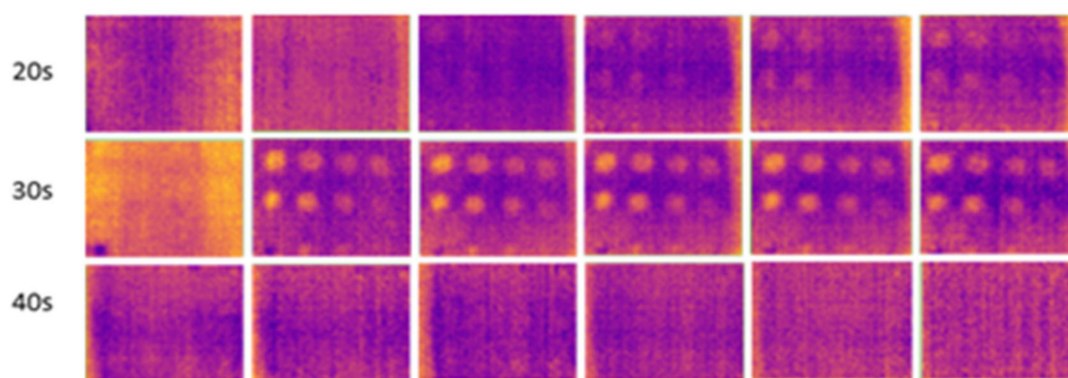
Figure 17. Output image for the yellow-colored background of the internal wall for 20–40 s of heating.

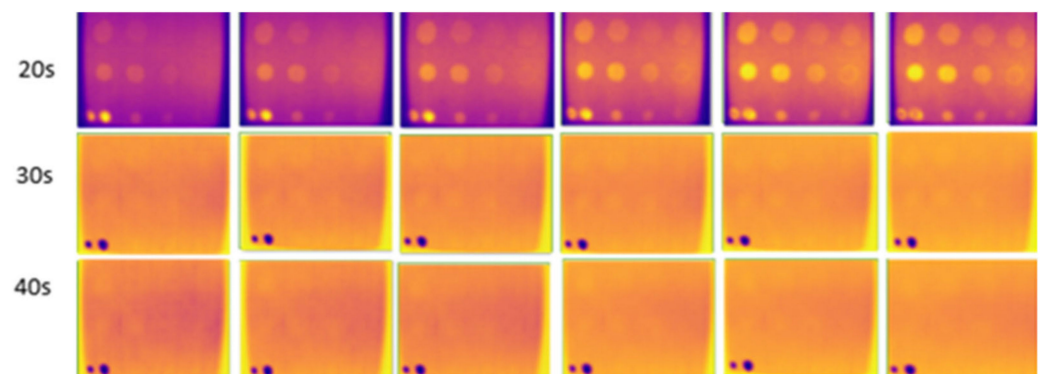
Figure 18. Result for indoors, without an enclosure at temperatures from 16 °C to 18 °C from 20 s (first row) to 40 s (last row) of heating.

Figures 18 and 19 show the results of experiments conducted indoors at 16 °C to 18 °C with and without an enclosure. At 20 s of heating, ten defects were observable, with slight variations during the cooling periods under the two conditions. The C1 defect, with a depth-to-size ratio of 0.206, remained undetectable. This experiment demonstrates that using a closed setup, such as an enclosure, minimizes heat loss and reduces interference from external heat sources like furniture and walls. The findings support previous studies that have demonstrated that the efficiency of detection results will improve with the use of confined spaces [44,71] and black-colored background material [32] in enhancing defect detection.

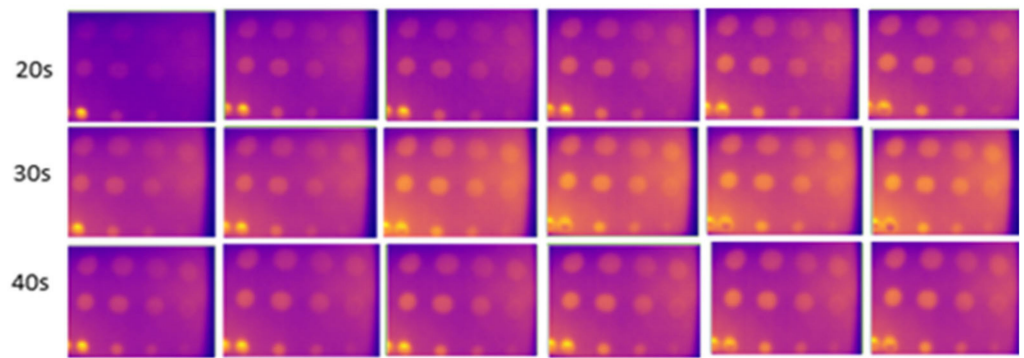
Figure 19. Result for indoors, using an enclosure at temperatures from 16 °C to 18 °C from 20 s (first row) to 40 s (last row) of heating.

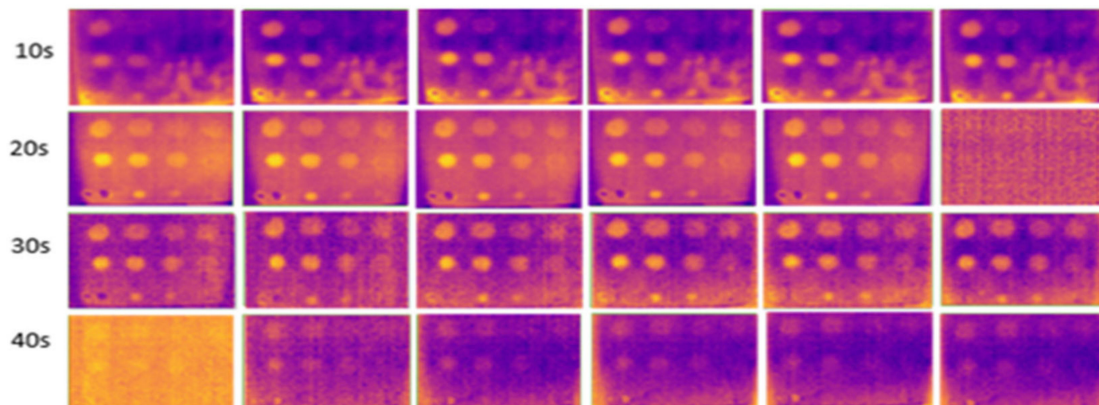
Figure 20. Without tape covered on the surface material at low temperatures (16 °C to 18 °C) from 10 s (first row) to 40 s (last row) of heating.

At 10 s of heating, the images captured with any surface emissivity were noisy, with fewer detected FBH defects, as shown in Figures 20–22. This is due to insufficient heat application on the GFRP material surface. As the heating duration extended from 20 to 30 s, more defects were detected. Images captured without black insulation tape were less noisy and clearer, with heat evenly distributed compared to other surface emissivities. Black tape, with a higher emissivity value of 0.97 compared to the GFRP surface (0.9), improved detection. At 30 s of heating, 10 defects were detected with black tape, though the B1 defect had poor visibility and the C1 defect remained undetectable.

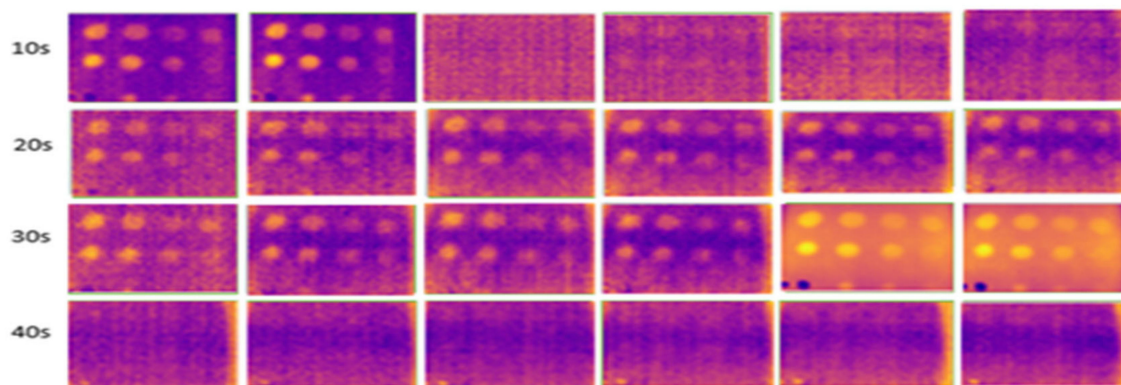
Figure 21. Yellow tape covered on top of the surface sample at low temperatures (16 °C to 18 °C) from 10 s (first row) to 40 s (last row) of heating.

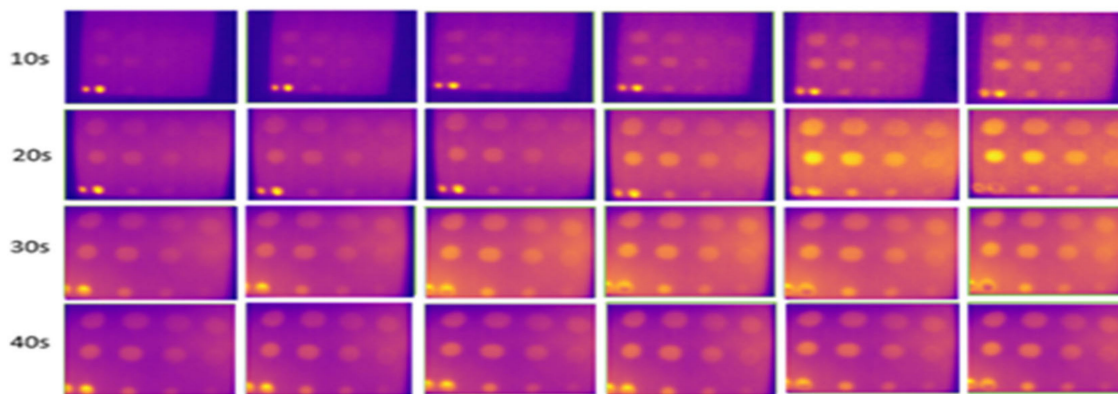
Figure 22. With black tape on the surface material at low temperatures (16 °C to 18 °C) from 10 s (first row) to 40 s (last row) of heating.

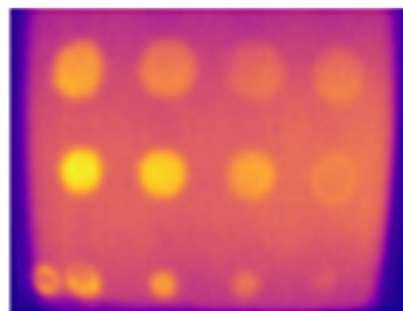
Figure 23. Optimized FBH defect of the GFRP detected.

The emissivity of the surface material was a crucial parameter in LPT. Surface GFRP typically exhibits a low emissivity value. Therefore, to enhance detection capabilities, applying black tape or black paint can improve the emissivity of the material. Figure 23 displays the results of the optimal values for each selected parameter. The analysis revealed that 10 defects were detected. However, defect B1, with a depth of 2.88 mm and a diameter of 21 mm, had low observability, while defect C1, with the same depth of 2.88 mm but a smaller diameter of 14 mm, had extremely low observability. Table 3 presents the optimal values for each evaluated parameter.

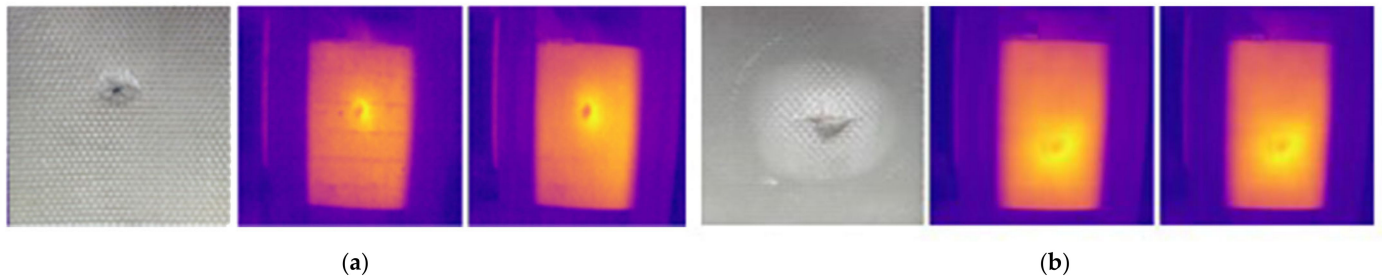
Figure 24. Impact defect detection results using optimized parameters for samples (a) B1 and (b) B2.

Figure 24 illustrates the assessment of samples B1 and B2 using optimized parameters using the LPT method. The impact defects on the composite material can result in matrix cracking and fiber breakage, as composites are anisotropic materials. The impact defects of samples B1 and B2 were clearly captured using the optimized parameters. Holes and damaged areas can also be seen in the images. However, detailed damage such as small crack sizes cannot be observed due to the low resolution of the IR camera used for capturing the images.

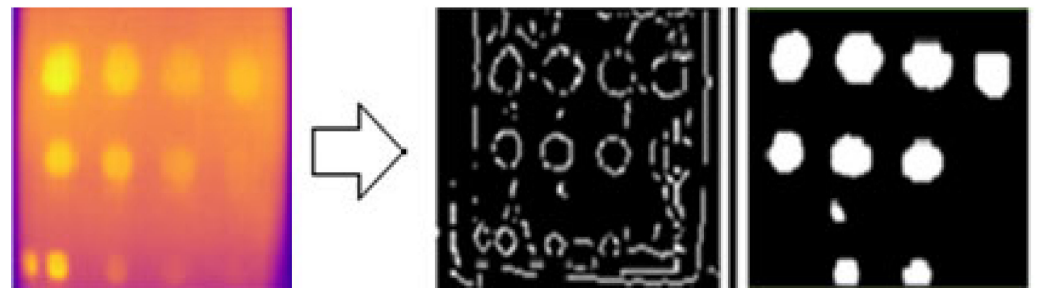
Figure 25. FBH depth defect detection process using Canny edge detection segmentation.

The results of the edge segmentation method for FBH depth defects on sample A are presented in Figures 25 and 26 for the Sobel and Canny operators, respectively. Several threshold values were tested to detect as many edge defect boundaries as possible. The Sobel operator at a threshold of 0.03 and the Canny operator at a threshold of 0.094 produced the optimal results. The Canny operator outperformed the Sobel operator, detecting nine defects compared to four with Sobel. However, some noise was mistakenly detected as defects in both operators.

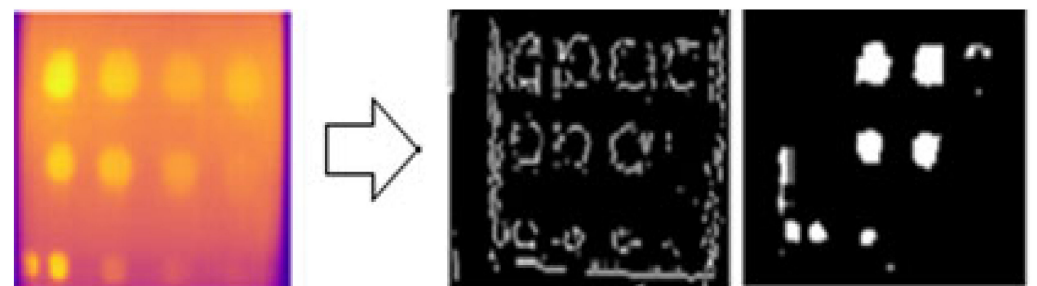
Figure 26. FBH depth defect detection process using Sobel edge detection segmentation.

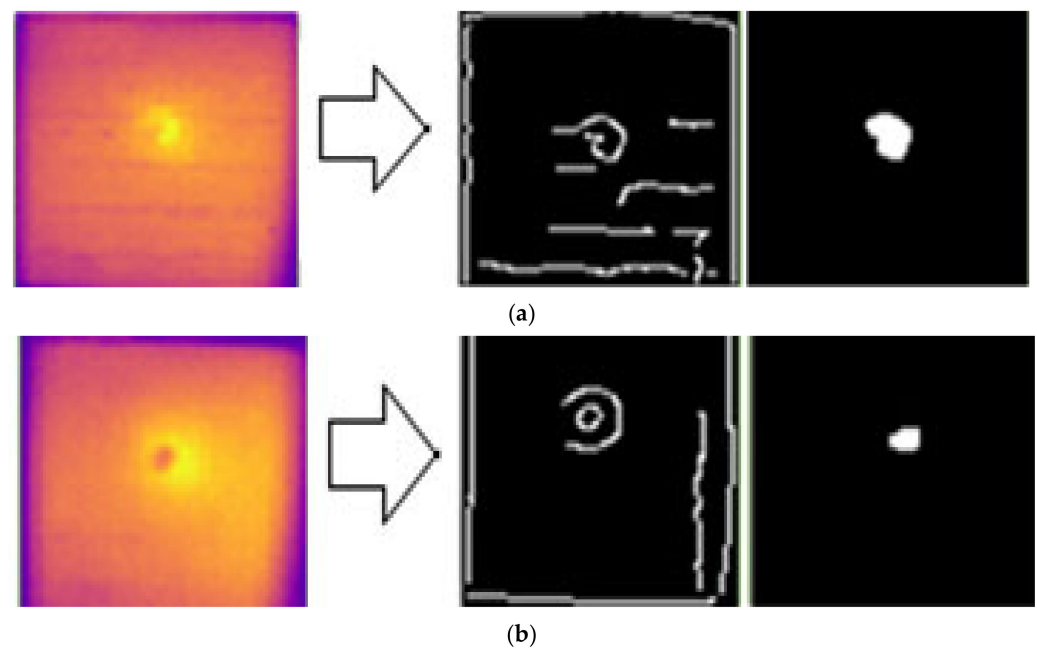
Figure 27. Edge image segmentation for GFRP impact defect detection using the Canny edge detection method for (a) defect IM1 and (b) defect IM2.

Figure 27 shows the output results of the Canny edge detection applied to the impact defects of the B1 and B2 samples. The results indicated that the edge detection method was able to detect the center of the impact defects. This method has the limitation of being unable to detect cracks and delamination surrounding the impact area. Additionally, for

impact defects, the shape of the defect changed after applying the morphological process to the image.

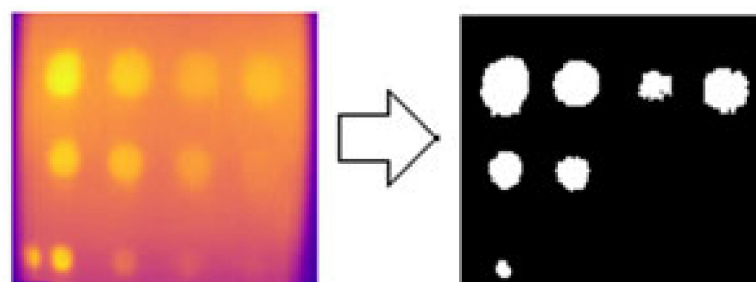
Figure 28. FBH depth defect detection using histogram threshold.

Another method of defect detection using image processing is histogram segmentation, which analyzes the histogram of an image and determines the pixel threshold value to distinguish between defective and non-defective areas. The optimal intensity threshold for histogram segmentation suitable for FBH depth and impact defects was found to be 200 pixels. However, using this method, only six defects were detected for FBH depth, including A1 to A4 defects and B3 and B4 defects, as shown in Figure 28. Moreover, the size of the detected defects appeared larger than the actual defect images due to heat distribution variability. The results for impact defects in Figures 29 and 30 also showed a wider area of defect detection. This occurred because the histogram segmentation in this study was based on light intensity, influenced by heat distribution during the cooling period, which may have covered a larger area than the defective region.

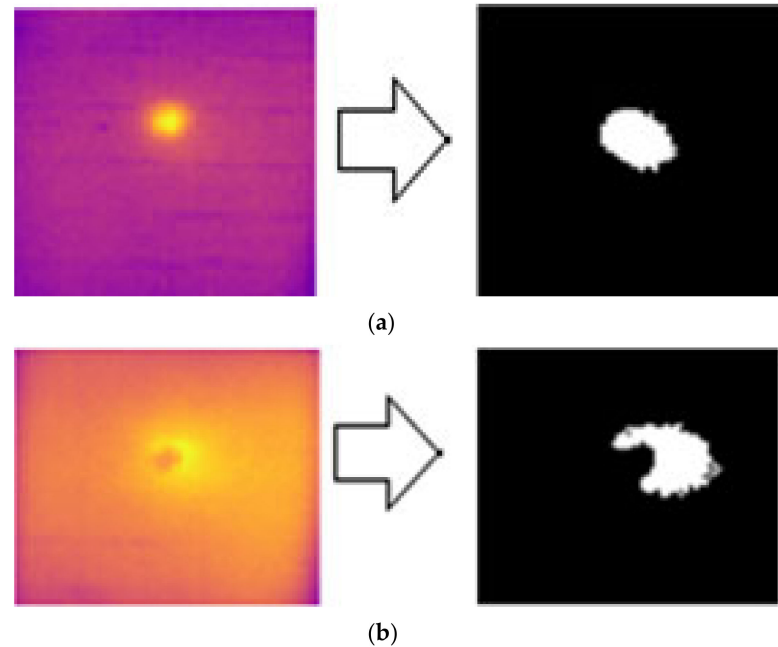
Figure 29. Histogram threshold segmentation method result for (a) defect IM1 and (b) defect IM2.
