## **ASSESSING THE SUSTAINABILITY OF THE KIAU NULUH – GURKHA HUT TRAIL, KINABALU PARK, SABAH, MALAYSIA**

### **ABSTRACT**

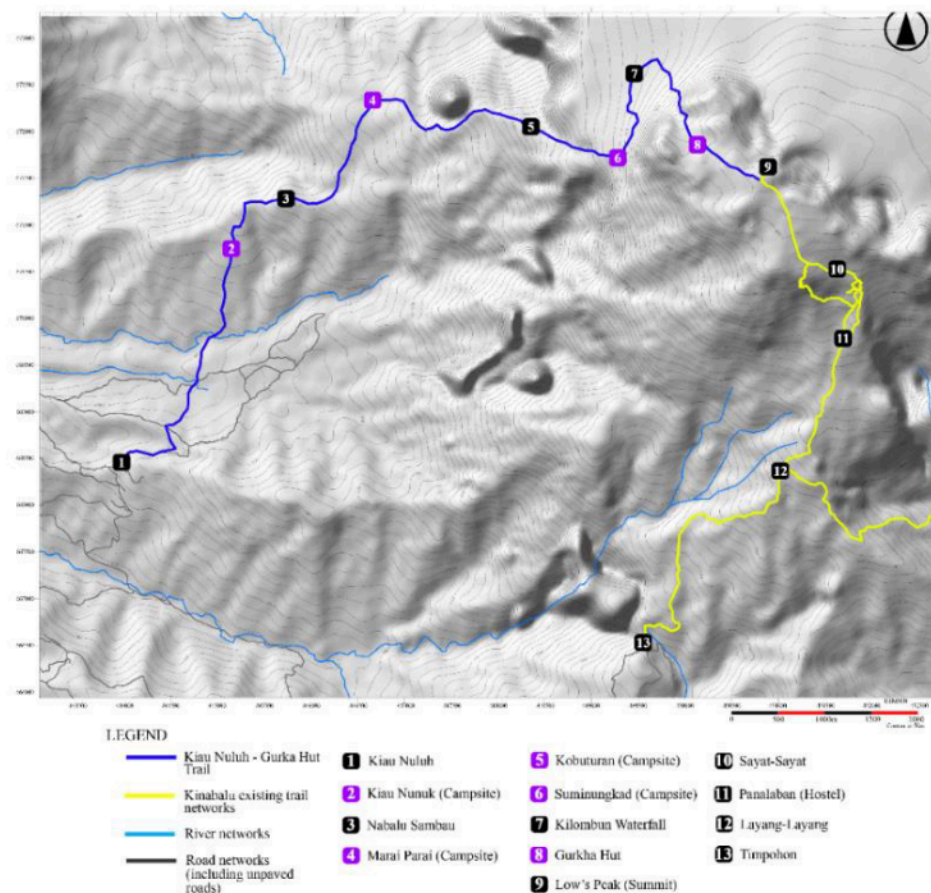
The study took place on the newly proposed Kiau Nuluh - Gurkha Hut Trail, as depicted in Figure 1. This trail originates from Kiau Nuluh, a village situated in the western region of the park, in the Kota Belud District, approximately 21.6km from Kinabalu Park's headquarters. The trail began at 979m asl and traversed into various forest types, including upper dipterocarp forest (750 – 1,200m asl), montane forest (1,200 – 1,500m asl), montane-ericaceous forest (1,500 – 2,700m asl), ultramafic rock forest (2,700 – 3,000m asl), and ended at Gurkha Hut, an area in the granite rock forest (3,800m asl) and alpine forest (3,800 – 4,095m asl) region.

**Figure 1. Route of the Kiau Nuluh – Gurka Hut Trail, Kinabalu Park.**

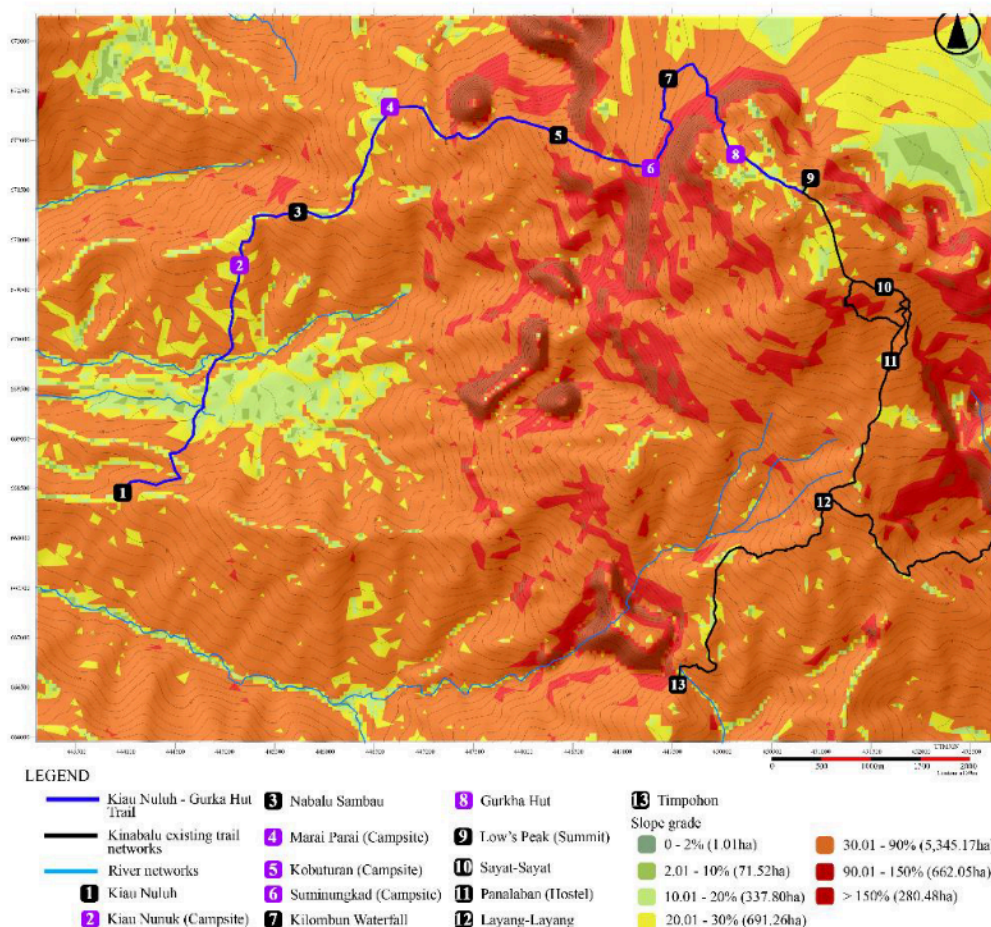
Further examination of the topographic features, utilizing Digital Elevation Model (DEM) data with a resolution of 30 meters obtained from the Shuttle Radar Topography Mission (STRM), has yielded significant insights into the 7,389.32 hectares surrounding the Kiau Nuluh – Gurkha Hut Trail (refer to Figure 2). The analysis reveals that 72.34% or 5,345.17 hectares of the area is characterized by slope gradients ranging between 30% and 90% (approximately 16.7 degrees and 41.99 degrees), with less than one percent of the slope grade falling below 10%. This observation illuminates why more than 70% of the assessed trail segments are classified as unsustainable according to Marion's (2023) trail sustainability rating. Additionally, a notable portion of the trail traverses the ridgelines, as evidenced by the contour lines, potentially representing the most accessible areas within the rugged terrain of Kinabalu Park's northwest region.

**Figure 2. Slope grade analysis of the Kiau Nuluh – Gurkha Hut Trail, Kinabalu Park.**
