**LIGHTNING DAMAGE DETECTION ON SOLAR PANELS USING  
PORTABLE INFRARED CAMERA AND CONVOLUTIONAL NEURAL  
NETWORK FOR ENHANCING PANEL MAINTENANCE**

**Thesis Submitted to the School of Graduate Studies, Universiti Putra  
Malaysia, in Fulfilment of the Requirements for the Degree of Master of  
Science**

**October 2024**

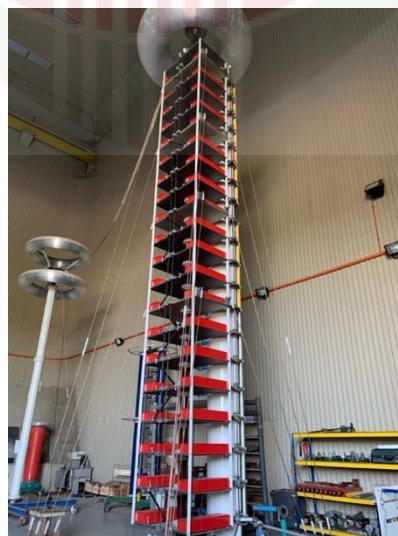
**Figure 3.4: The multistage Marx impulse generator**

A multistage Marx impulse generator induced the lightning strike effect, as in Figure 3.4.

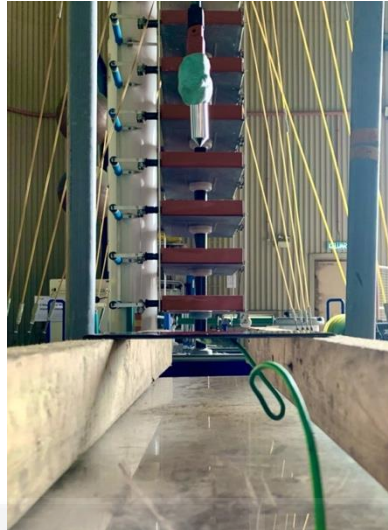
**Figure 3.5: The experiment setup (side profile)**

The samples were placed on a wooden surface with grounding. Figure 3.5 shows the side profile of the experimental setup. Since this is a high voltage testing, excess electrical charge that could build up on the samples during the test is dispersed using grounding. Inadequate grounding increases the possibility of electrical arcing, which may damage equipment and risk people's safety. Moreover, electrical energy is usually released into the atmosphere when lightning strikes. The test arrangement more closely resembles the circumstances of an actual lightning strike by grounding the samples, improving the test results' accuracy and dependability. The experimental setup is shown in Figure 3.5 and Figure 3.6.

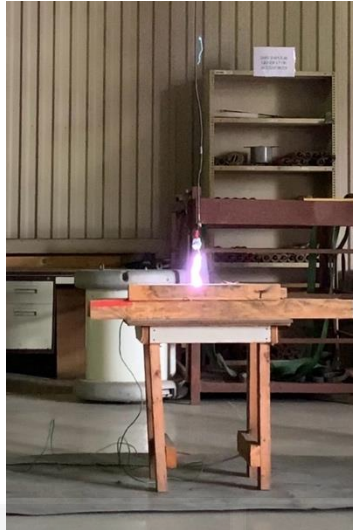
**Figure 3.7: Lightning strike induced on sample**

Different impulse voltage intensities were induced to observe the intensity of damage to the solar panels. The experiment started with a 20kV impulse voltage and increased it to 30kV. 30kV was set as the threshold voltage. The threshold voltage was set to identify the point where damage starts appearing on samples by exposing samples to a variety of impulse voltage levels. This threshold voltage gives important information about the electrical insulating qualities of the material and indicates its vulnerability to electrical stress. This research used 30kV, 60kV and 90kV as the impulse voltage for three monocrystalline and three polycrystalline panels. Figure 3.7 shows the lightning strike being induced on the sample.

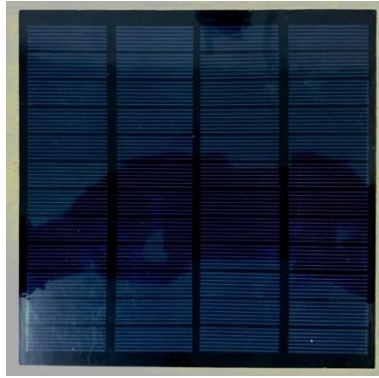
**Figure 4.1: Damaged M1 sample (30kV)**

All these panels showed different behaviours when tested for different impulse voltages. The panels were looked at for visible damage on the surface. For monocrystalline, sample M1 showed no visible damage when exposed to 30kV impulse voltage. Meanwhile, sample M2, which induced 60kV impulse voltage, had minor peeling at the edge of the panel but no other damage on the surface. However, sample M3 had no visible damage when exposed to 90kV impulse voltage.

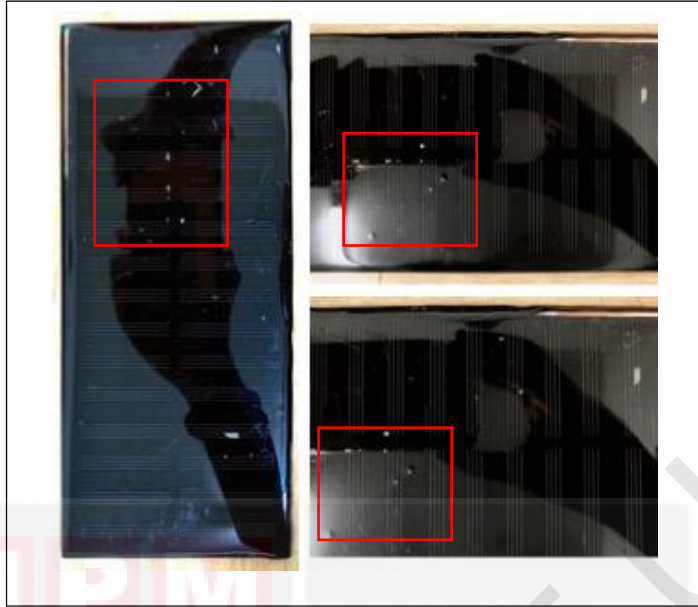
**Figure 4.4: Damaged P1 sample (30kV)**

For polycrystalline samples, P1 showed the formation of small bubbles on the panel's surface after being exposed to 30kV impulse voltage. A minor dent with 0.2 cm and small bubbles on the surface were noticed on sample P2, which induced 60kV impulse voltage. However, sample P3 shows no visible damage after exposure to 90kV impulse voltage.
