**DAMAGE SEVERITY EVALUATION METHODS FOR BIOCOMPOSITE
VERTICAL AXIS WIND TURBINE BLADES DUE TO LIGHTNING
STRIKES**

FK 2019 43

**Thesis Submitted to the School of Graduate Studies, Universiti Putra
Malaysia, in Fulfilment of the Requirements for the Degree of Doctor of
Philosophy**

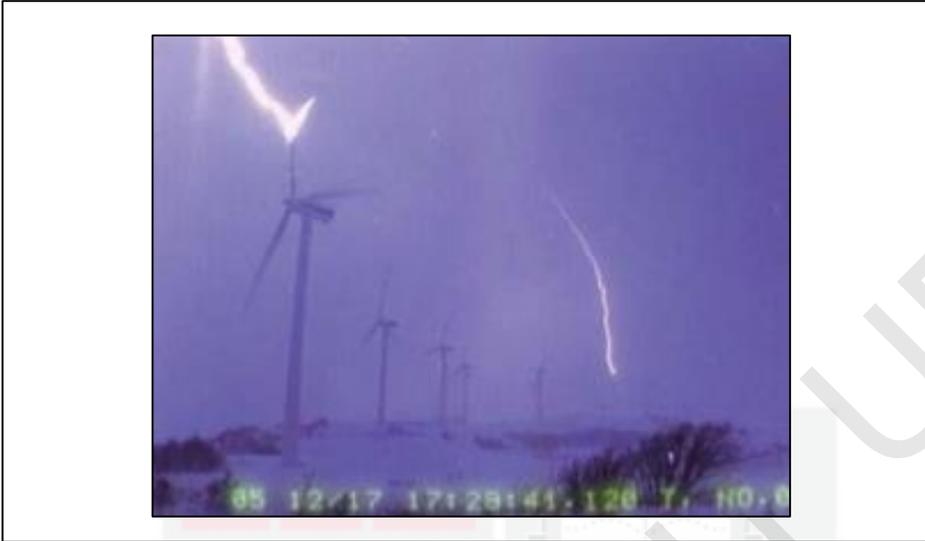
Figure 1. 1: Lightning strike on a turbine blade (D. Li et al., 2015)

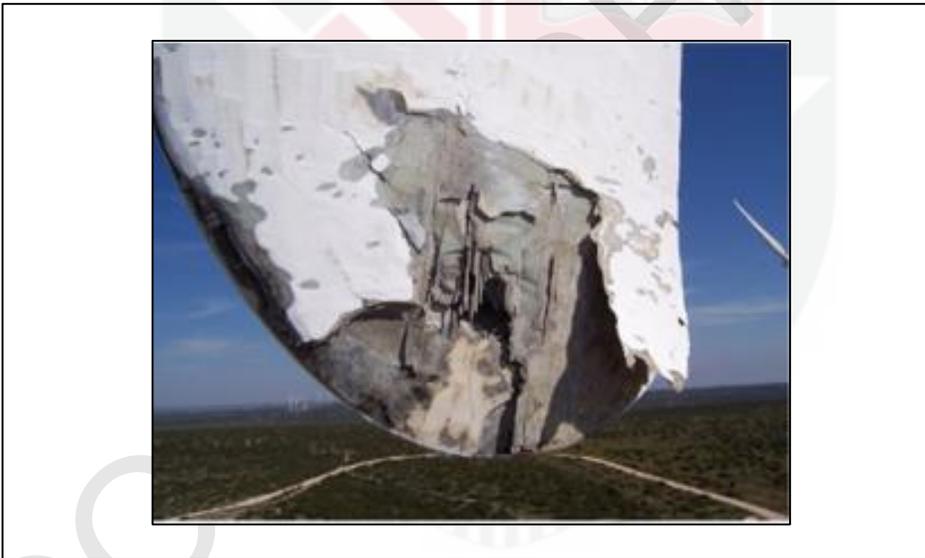
Figure 1. 2: Lightning damage due to lightning strike (D. Li et al., 2015)
