## Stability of Embankments on Soft Ground – Lessons from Failures

**Bujang B.K. Huat**

*Faculty of Engineering*

**Keywords:** embankment, failure, soft clay

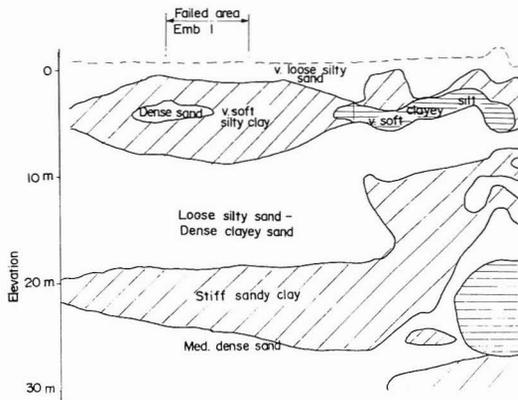
Fig. 2(a). Subsoil profile of embankment 1

Fig. 2(a), 2(b) & 2(c) show subsoil profiles of each of the embankments as obtained from the site investigation carried out during the design stage. In general they comprise soft silty clays of 7 m – 13 m thickness, underlain by a layer of loose to medium dense sand. The liquid limits of the soft clays vary from 50% – 120% with natural water content close to the liquid limit, and plasticity indices in the range of 30% – 80%. Undrained strengths obtained from the vane test show a general trend of strength ( $S_u$ ) increase below a weathered upper crust which varies from 1 m – 1.5 m in thickness (Fig. 3), with  $S_u/\sigma_c$  ratio in the range of 0.3 – 0.4. The clays are shown to be moderately sensitive, with sensitivity ratios in the range of 3 – 12. Results obtained from the oedometer tests indicated that the clays are slightly over-consolidated but highly compressible. This apparent over-consolidation of the clay is believed to be due to that of the weathered crust. The values of  $C_v$  are typically low, ranging from 1 – 10m<sup>2</sup>/yr.

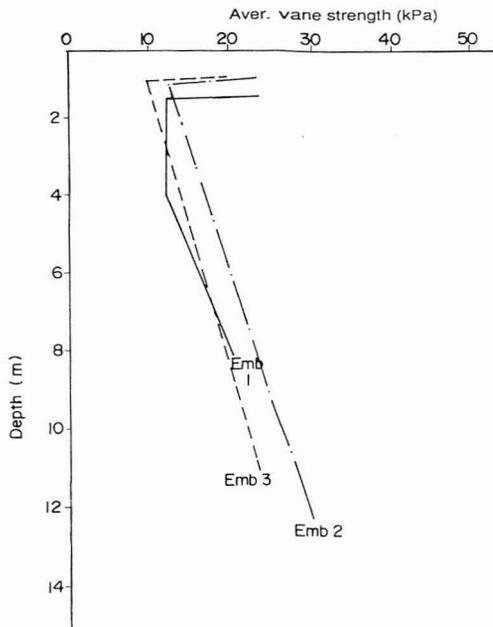
Fig. 3. Average vane strengths

For the clay foundation, the average vane strengths shown in Fig. 3 are used as input parameters. These were corrected with Bjerrum's (1973) correction factors for the effect of anisotropy and shear rate. As shown in Fig. 7,

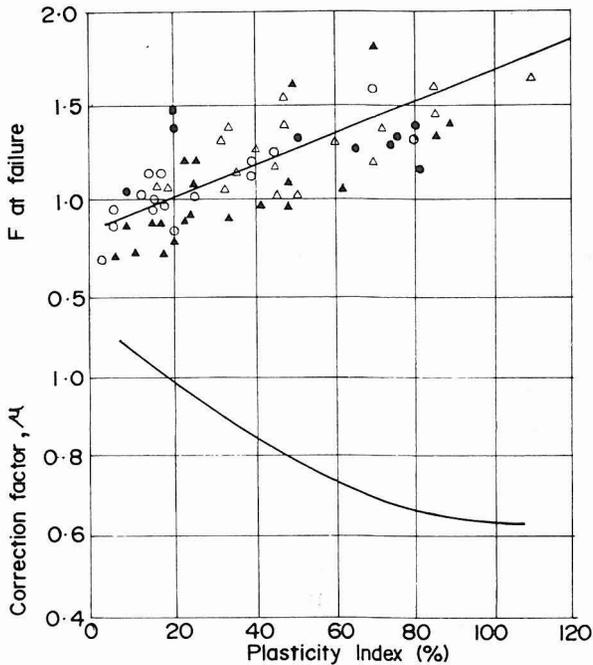
Fig. 7. Relationship between calculated factor of safety and plasticity index for embankment failures, and deduced correction factors for measured vane strengths (Bjerrum 1973)

for plasticity index of 30 - 80%, the correction factor applied is between 0.7 - 0.9. It is of interest to note that the corrected average vane strength of the clay lies close to the lower bound of the field data (See Fig. 5, 6). Note also that for embankment 3 surcharge loading of the traffic is accounted for, estimated in the order of 10 kN/m<sup>2</sup>. The results of the calculation are summarized in Table 2.

The factors of safety of the embankment at failure are essentially equal to unity. This indicated that given representative strength parameters have been obtained for both fill and foundation, the total stress analysis is sufficient for short-term failures of embankment on soft clays, i. e. till end of construction time. It has been suggested that the total stress analysis offers an unambiguous way of estimating stability (Pilot 1972; Brand, 1983; Wolski *et al.* 1989).
