Analysis of Longitudinal Cracks in Crest of Doroodzan Dam

KEYWORDS: Earth fill dam, Seepage, Longitudinal Crack, Doroodzan dam.

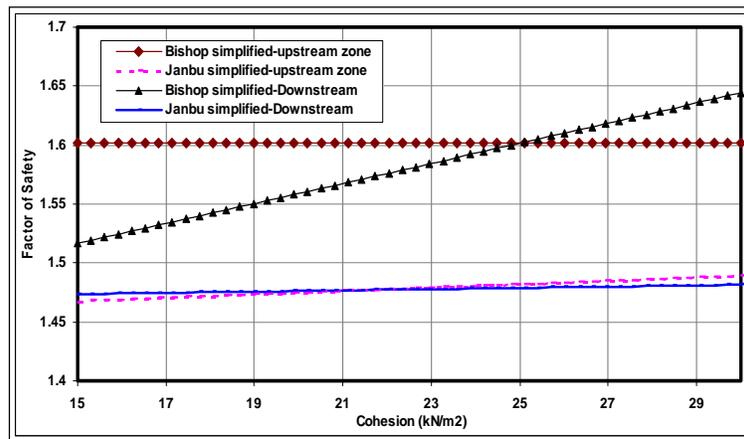
Figure 8: Effect of cohesion in downstream and upstream factor of safety based on Bishop and Janbu methods

Figures 8 to 11 illustrate different parameter changing effect during becoming saturate on downstream side of crest in Doroodzan dam. As a result, the most influential parameter is internal friction angle [ϕ] which by a slight decrease factor of safety sharply decreases. It could be done during saturation process. It means that by expanding the saturation zone, both cohesion and internal friction angle will decrease to their lowest level, because of leakage through the dam body and also capillarity forces.
