Slope Assessment Systems: A Review and Evaluation of Current Techniques Used for Cut Slopes in the Mountainous Terrain of West Malaysia

Harwant Singh

ABSTRACT

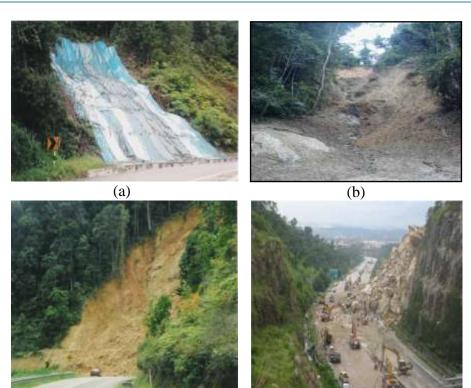
Figure 1: Some common types of landsides in Malaysia (a) Shallow slide, (b) Debris flow, (c) Deep seated slide (d) Rock fall.

The most common type of landslides in Malaysia is the shallow slide where the slide surface is usually less than 4 m deep and occurs during or immediately after intense rainfall (Ali Jawaid, 2000). These slides commonly occur in the residual soils mantles of grade V and grade VI according to the commonly used classification systems of Little (1969). Other types of landslides found are deep-seated slides, debris flow and geologically controlled failures such as wedge failures and rock fall. A slide is defined as the downward displacement or soil (or rock) sliding along one or more failure surfaces, rotational for the case of few units; translational for the case of many units (Varnes, 1978). Flows consist of the movement of slurry of soil and loose rocks down slope in a manner analogous to a viscous fluid. Falls are incidence of masses of rocks detaching from a steep slope and descending by free fall, rolling or bouncing. Figure 1 depicts some common landslide types found in Malaysia.
