***SCANNING LASER THERMOGRAPHIC SYSTEM FOR
NONDESTRUCTIVE EVALUATION OF INCIPIENT THERMAL DAMAGES
IN AIRCRAFT COMPOSITE PANEL***

**Thesis Submitted to the School of Graduate Studies, Universiti Putra Malaysia
in Fulfillment of the Requirements for the Degree of Master of Science**

May 2018

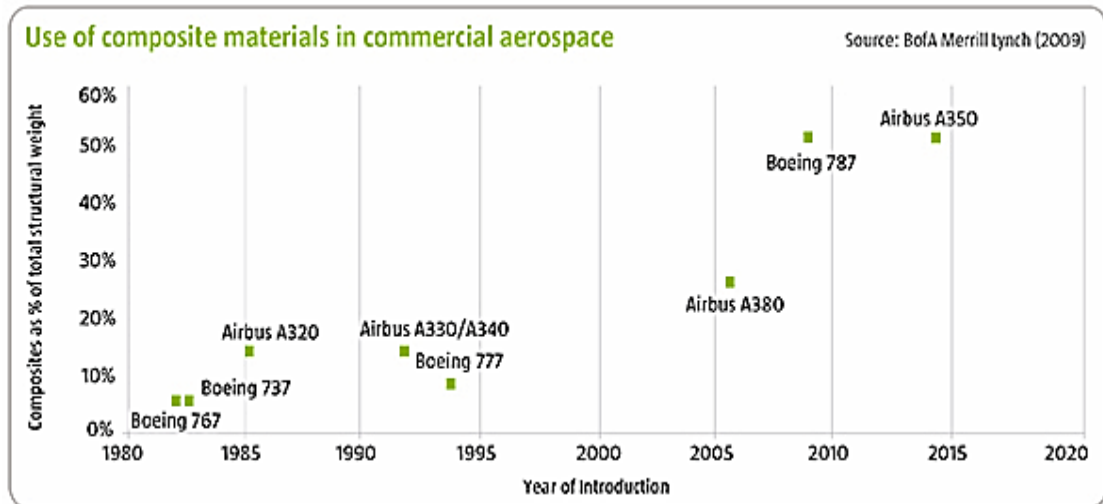
Figure 1.1 : Percentage of composite per weight over time (“No Title,” 2009)

In aerospace structure, composite have been applied in both primary and secondary part of aircraft. Graph illustrated in Figure 1.1 stated number of composite weight percentage over time since 1980s (“No Title,” 2009). Initially, composite was applied on secondary part only where composite percentage is lower than 5%. In 60 years, number of composite percentage has been increasing up to 50% and used at both primary and secondary structure. Primary structures in aircraft are structure that carries flight, ground, loads and whose failure would reduce the structural integrity of the aircraft or may causes injury and death to passenger or crew (Cutler, 2006). This part will carry critical load bearing structure on an aircraft and plays important role during service. Examples of primary structure of an aircraft are fuselage, wing spar, and wing rib. In other hand, secondary part is non-primary part and mainly functionalize to provide enhanced aerodynamics to aircraft. Differ from primary structure, failure at this part will be less critical and would not reduce the structural integrity of the aircraft. Among listed secondary parts are floor and other ancillary structure such as windows and fairing (Cutler, 2006)(Rupke, 2002). Figure 1.2 shows illustration by Airbus
